Land at Coventry Stadium, Brandon

Designer's Response to Stage 1 RSA
of Proposed Internal Site Layout

Road Safety Audit
Stage 1

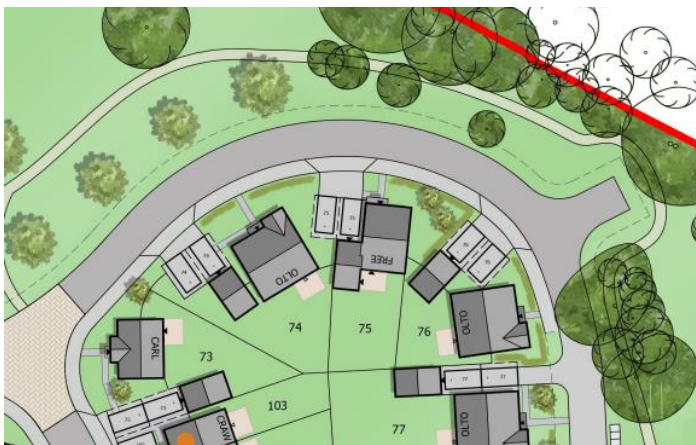
Figure 1: Proposed layout of dwellings

Location: Internal layout dwellings 73 to 76.

Summary: Lack of visibility for dwellings 73 to 76 may result in conflict.

Dwellings 73 to 76 are located on a bend in the carriageway which is described as a Green Lane (5.0m in width). Apart from the road width, the Audit Team do not have information on what this Green Lane represents. Although it is noted that traffic flows and vehicle speeds are likely to be low, the Audit Team is concerned that inter-visibility between exiting and approaching vehicles may be insufficient, increasing the risk of conflict between turning and ahead traffic.

- 2.2 The auditor's recommendation is accepted and the visibility at these plots has been reviewed further.
- 2.3 Importantly, there are two factors regarding visibility one of which is junction visibility and the other is the stopping sight distance (SSD) and whilst both are calculated using the same measurements the purpose of them is different. The junction visibility is provided to ensure that a driver exiting the junction can see an appropriate distance along the carriageway so that they can make an informed decision of whether they consider it is safe to pull out and the distance is based on the time taken for an approaching vehicle to stop. Traditionally this has been measured to the nearside kerb line or as per Manual for Streets 2 (MfS2) to the nearside edge of the vehicle track. Both allow for an overtaking vehicle to be seen.

- 2.5 Clearly, therefore, the importance of this is to ensure an approaching driver can see any vehicle likely to emerge from a driveway into the path of their vehicle. As demonstrated on **Drawing 16115-18** attached as **Appendix C**, the forward visibility splays have been derived based on a 15mph design speed which is considered reasonable on this section given its alignment and its status within the overall development scheme. The drawing demonstrates minor encroachment on the front of some of the development plots and it is proposed that residents of those plots would be prevented from planting anything above 0.6m where the splays are shown. This would be secured through the Section 106 Agreement.

Recommendation

Confirm visibility splays are appropriate for expected vehicle speeds. Additional speed reducing features may be required to further lower speeds.

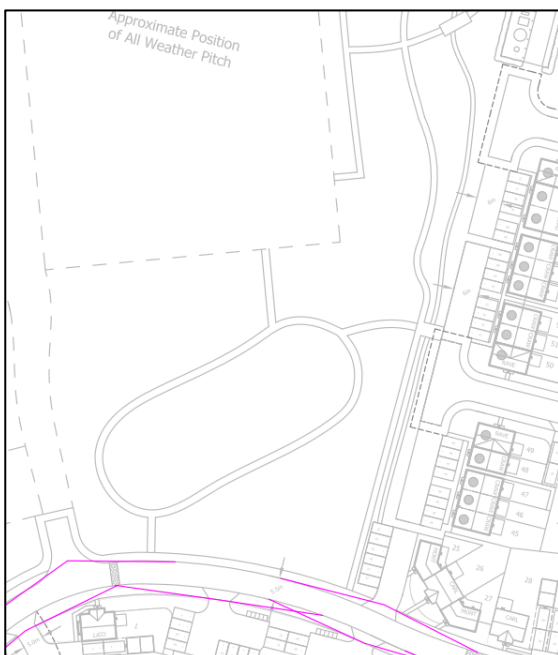
Figure 2: Proposed All-weather pitch

Location: Residential roads near all-weather pitch.

Summary: Vehicles may park on-street restricting access and preventing turning movements leading to conflict.

An all-weather pitch is proposed as part of the development for which the Audit Team do not have the full details in relation to the parking. The Audit Team is concerned that should insufficient parking be provided, vehicles may park on the residential roads and potentially within the turning heads. Parking within the turning heads may restrict access to driveways and prevent road users from being able to turn which may result in inappropriate turning movements increasing the potential for conflict. Significant numbers parking on-street may restrict the free flow of traffic or should vehicles park partly on the footway, pedestrians may be forced into the carriageway, increasing the risk of conflict.

- 2.6 The auditor's recommendation is accepted. The level of parking has been informed by discussions with potential operators and is considered to represent an appropriate level of parking to accommodate expected demand. Consequently, it is considered unlikely that overspill parking onto residential streets would occur in practice. It is proposed however that the demand for car parking associated with the all-weather pitch will be monitored and the need for further restrictions kept under review.

Recommendation

Provide sufficient off-street parking for the all-weather pitch. Parking restrictions may be required, particularly within the turning heads.

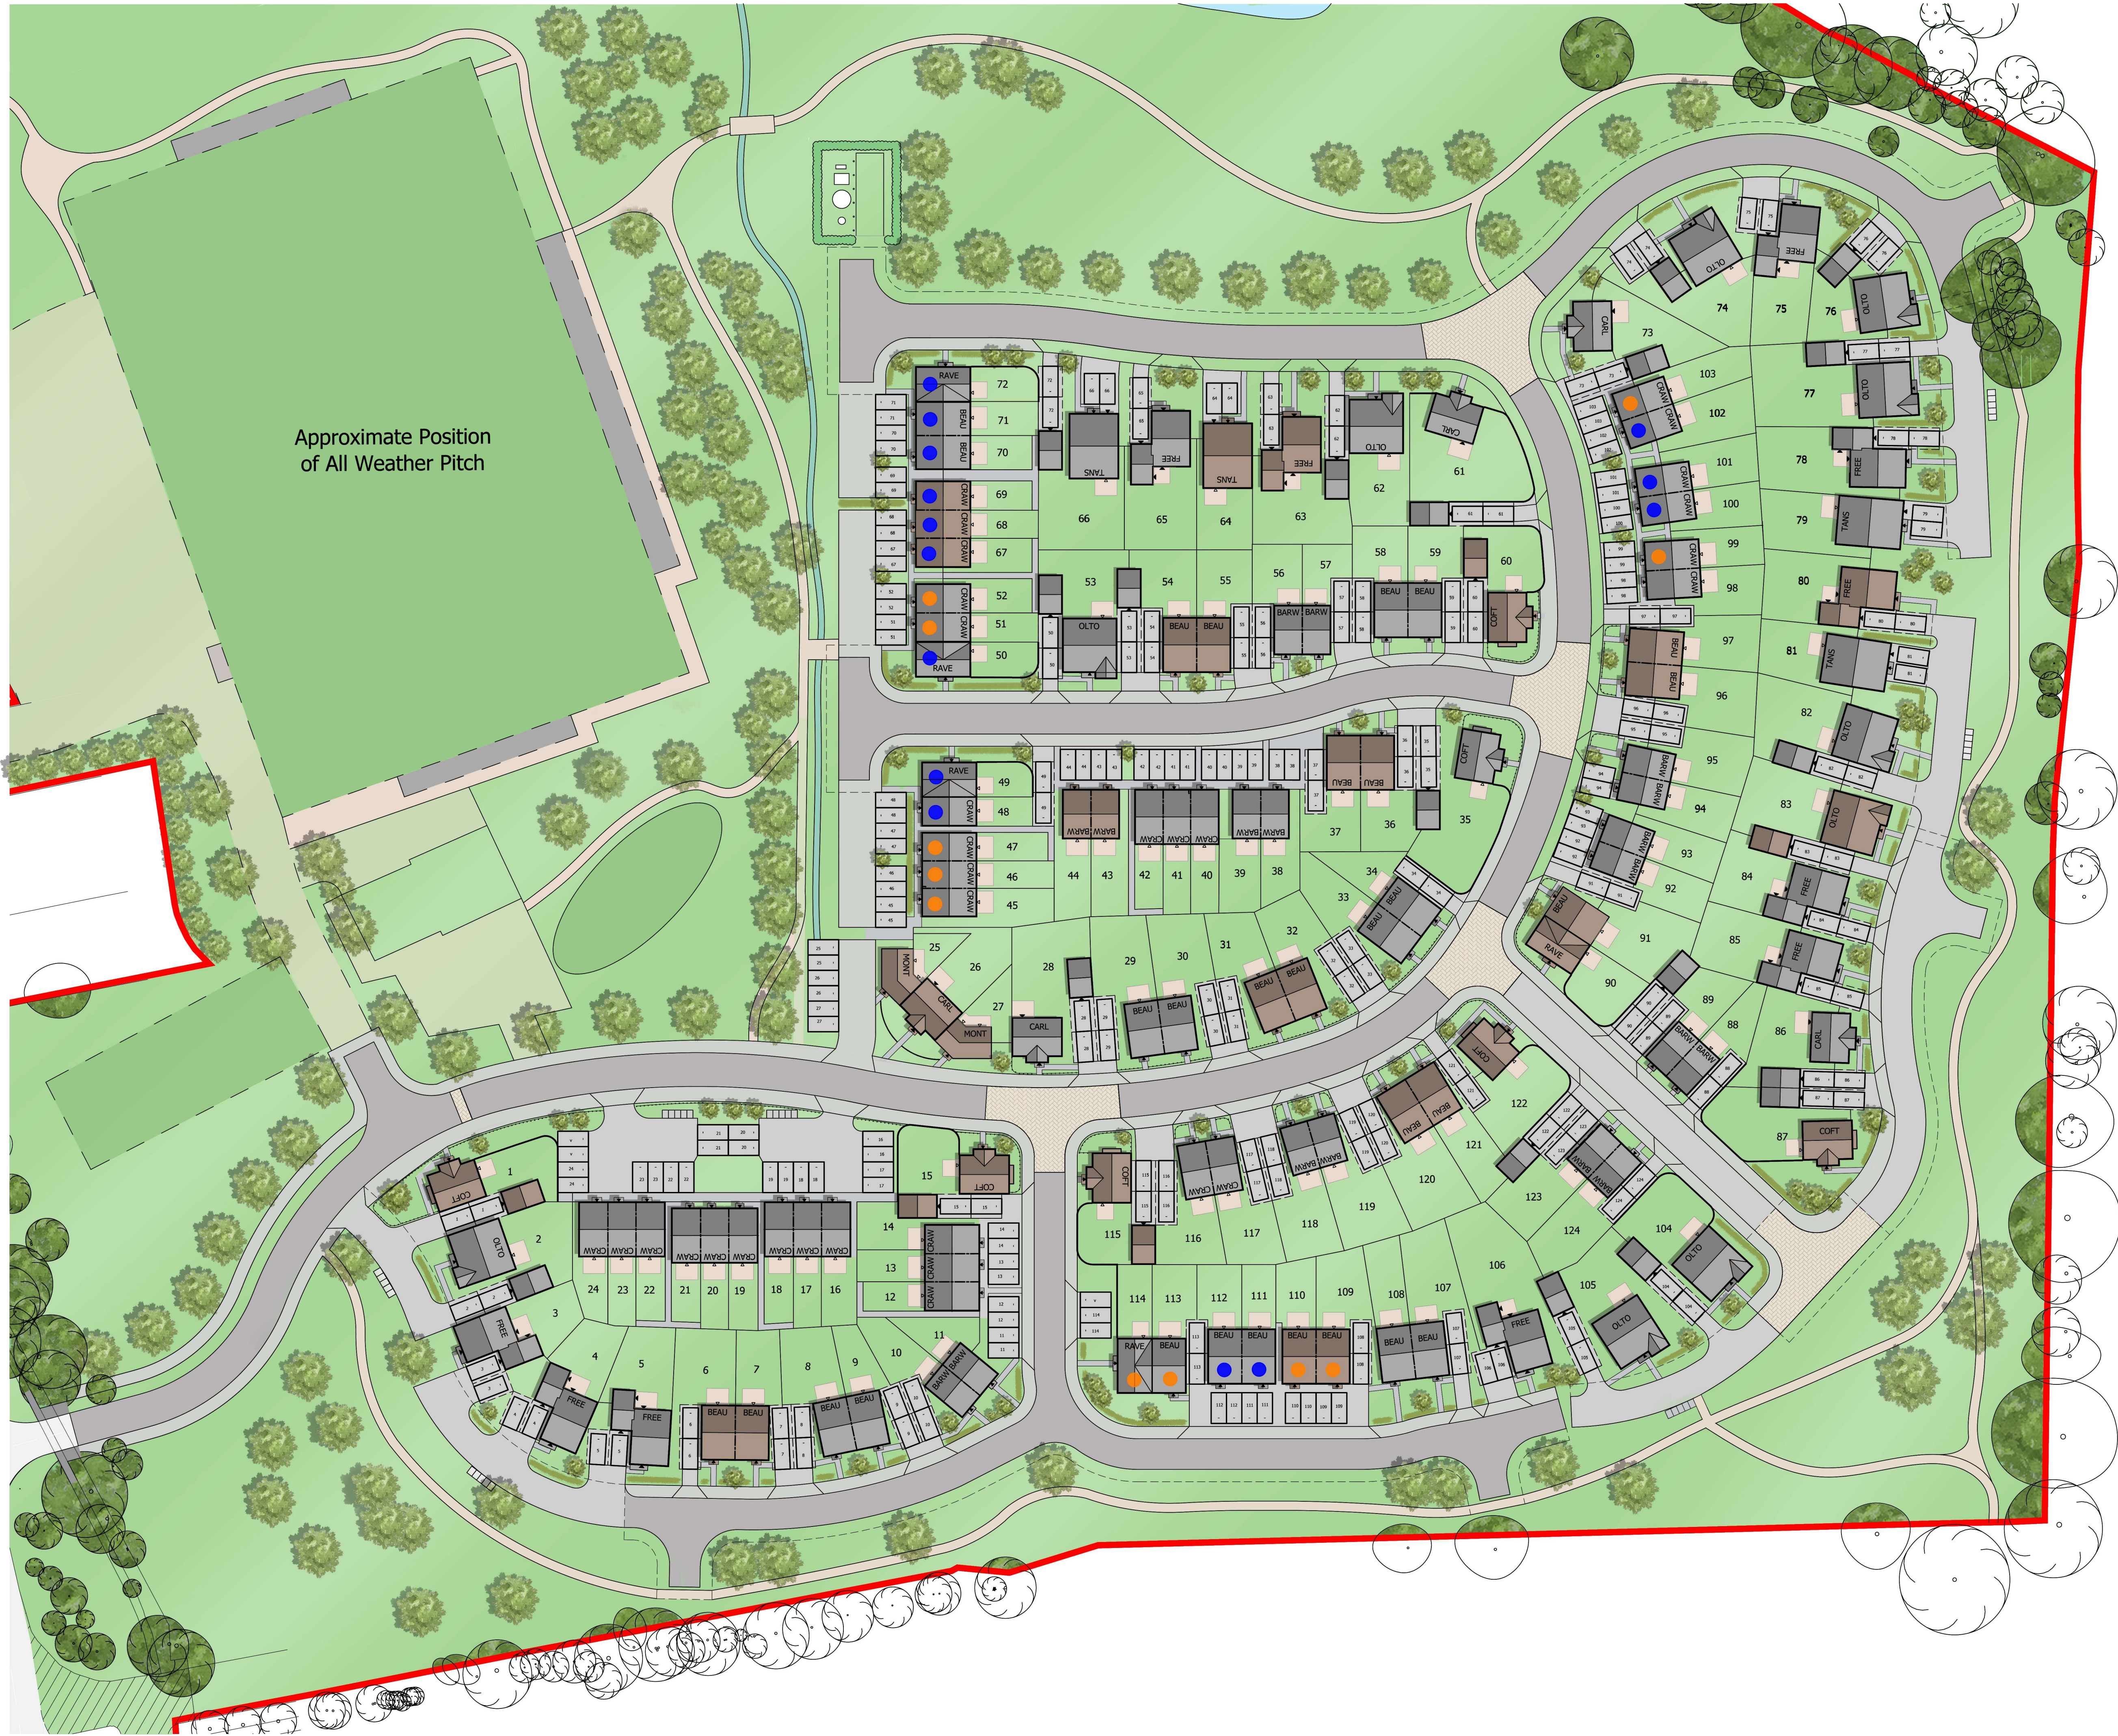
Appendix B

| Rev | Amendments | Date |
|---|--|---|
| C | Footpath connections added. | 23.05.22 |

- 2.1 The auditor's recommendation is accepted. In addition to connections being provided to the north, south and west, additional links have been shown to the east as set out on the revised site layout plan attached as **Appendix B**. These are located opposite plots 76 and 105.

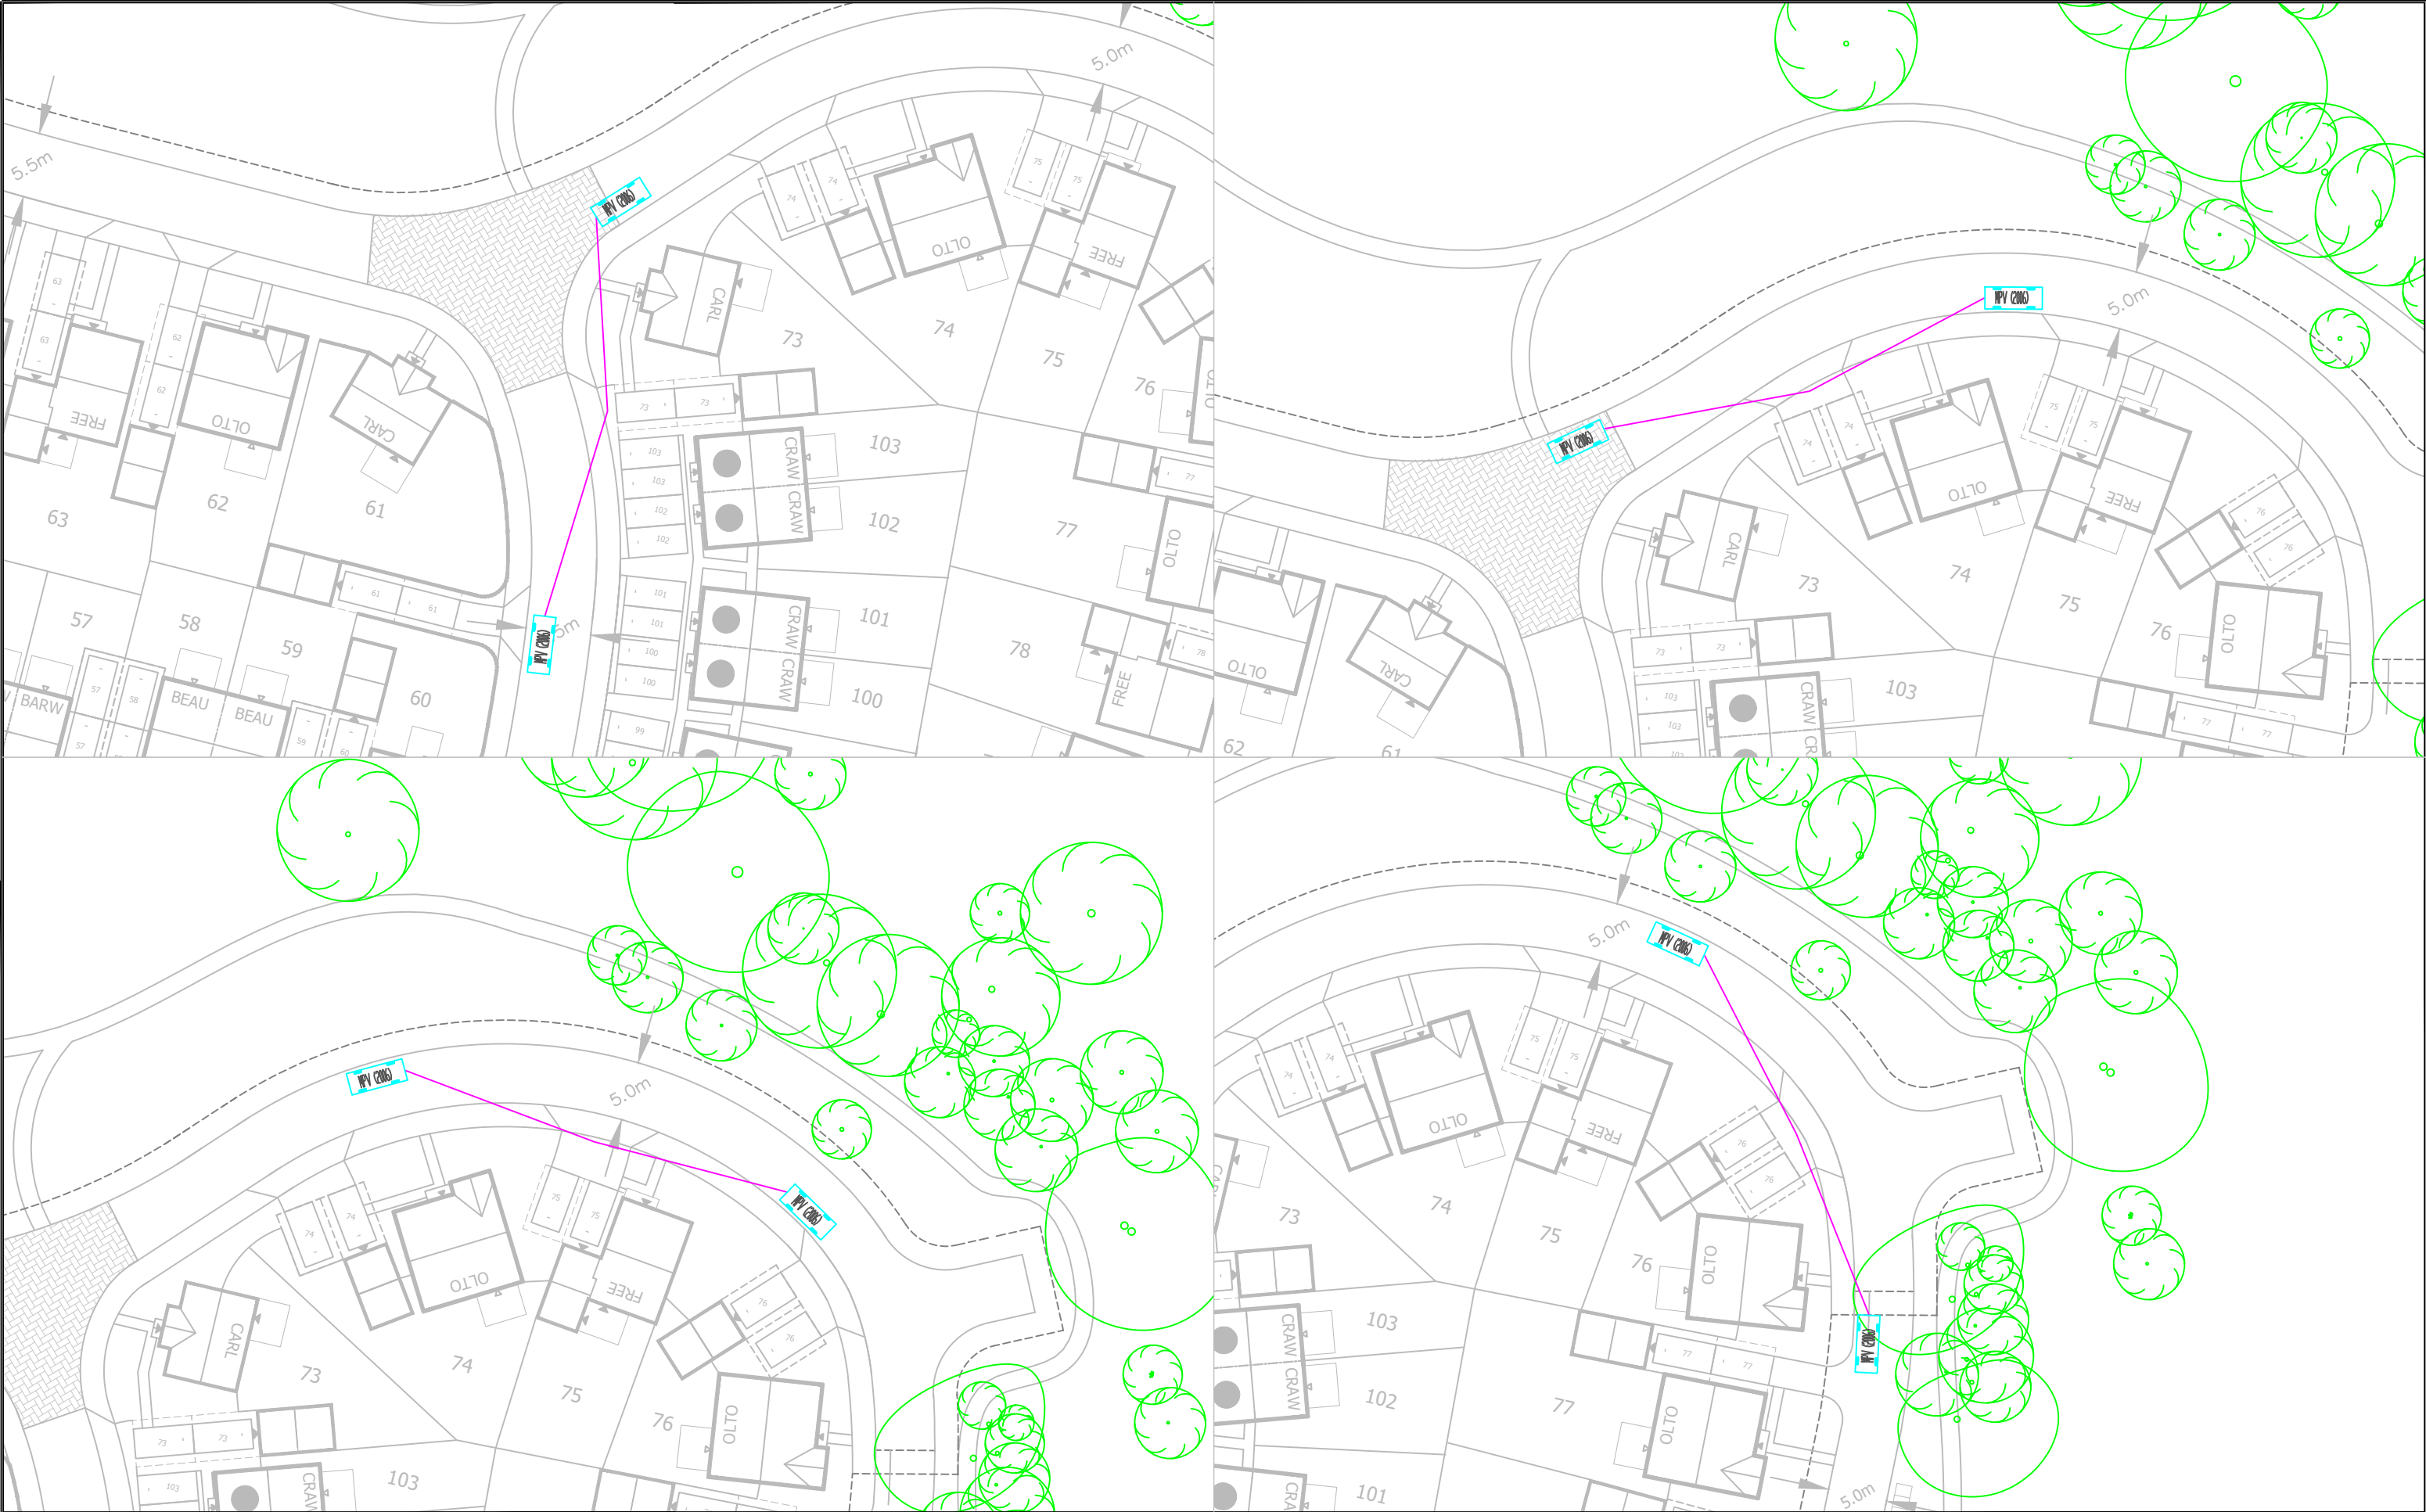
| JOB TITLE | | CLIENT | |
|---|---|---|---|
| 1: 500@A3 | TM | 20.09.21 | 16115-18 |

| JOB TITLE | | CLIENT | |
|---|---|---|---|
| Driveway Visibility Splays @17m (Based on 15mph Vehicle Speeds) | | | |
