# **DESK STUDY REPORT LAND EAST OF RUGBY ROAD CLIFTON-UPON-DUNSMORE, RUGBY**

**Prepared for: Richborough Estates Limited**

**ASL Report No. 259-24-087-11Rev2**

**August 2025**

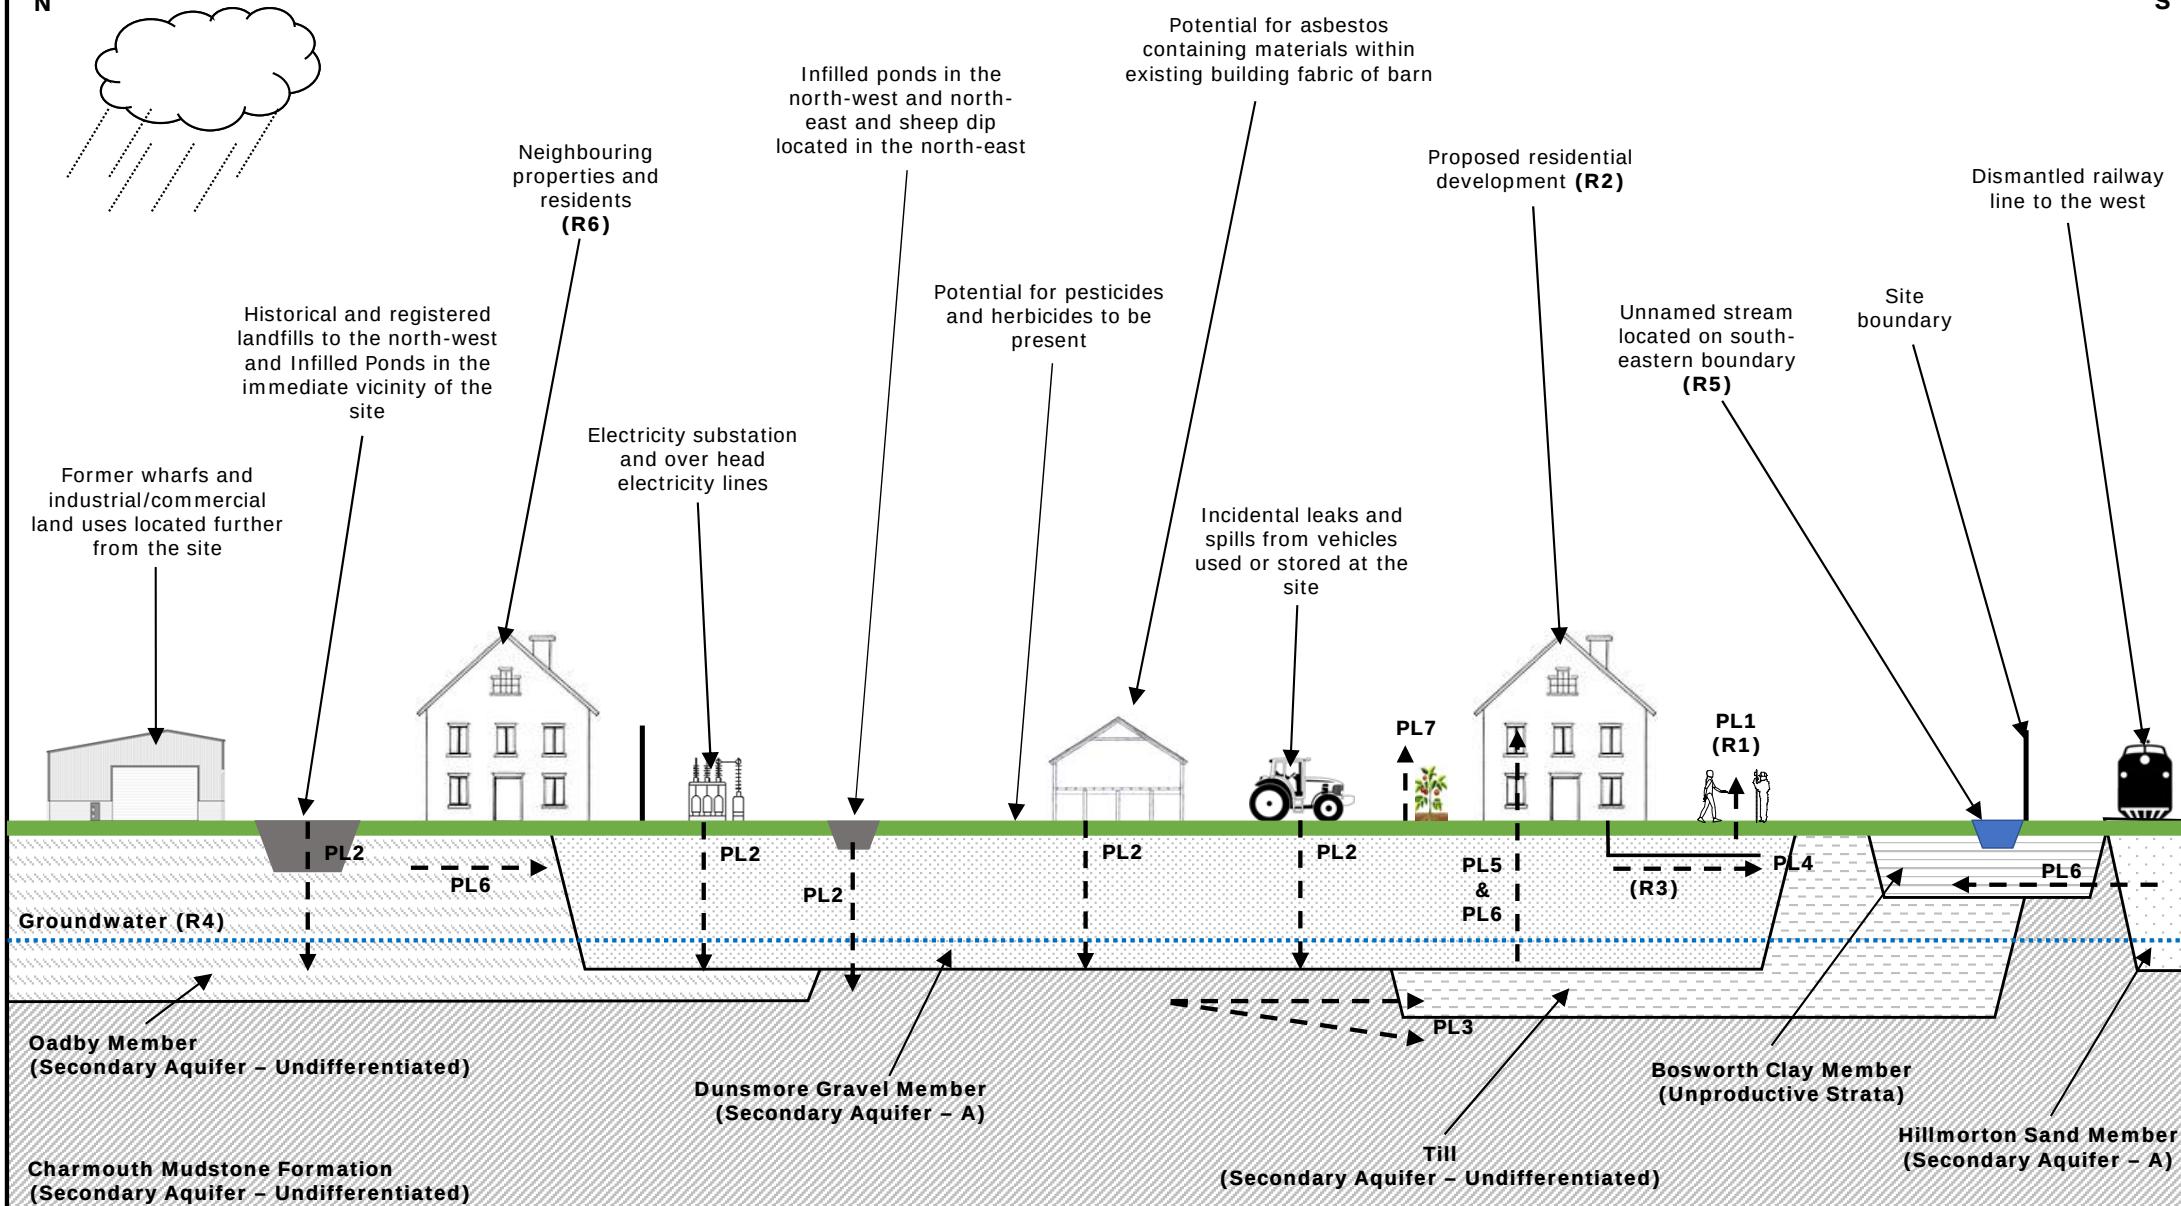
| Drawing No. | <b>Figure 3</b> |

| Drawing Name | <b>Conceptual Site Model</b> |

The desk study has identified potentially viable pollutant linkages that may pose a risk to human health. The potential sources of contamination identified at the site are generally considered to be the potential for Made Ground to be present and the potential presence of asbestos containing materials particularly in the vicinity of the existing barn. Additionally, a low risk associated with the potential presence of pesticides and herbicides and hydrocarbon contamination has been identified. The CSM has also identified a low risk from incidental leaks and spills from vehicles or machinery and from the potential presence of pesticides and herbicides.

Based on the findings of the conceptual site model, an intrusive investigation is recommended to determine the actual risk posed from contamination and hazardous ground gas and therefore the need for remediation. At this stage, it is considered likely that risks at the site could be reduced to an acceptable level by the use of mitigation measures including cover layers and gas resistant membranes at the proposed development.
