# Bat Assessment Report

Coventry Stadium  
Rugby Road  
Coventry  
CV8 3GJ

Brandon Estates Ltd.

(13<sup>th</sup> October 2017 - REVISION B)

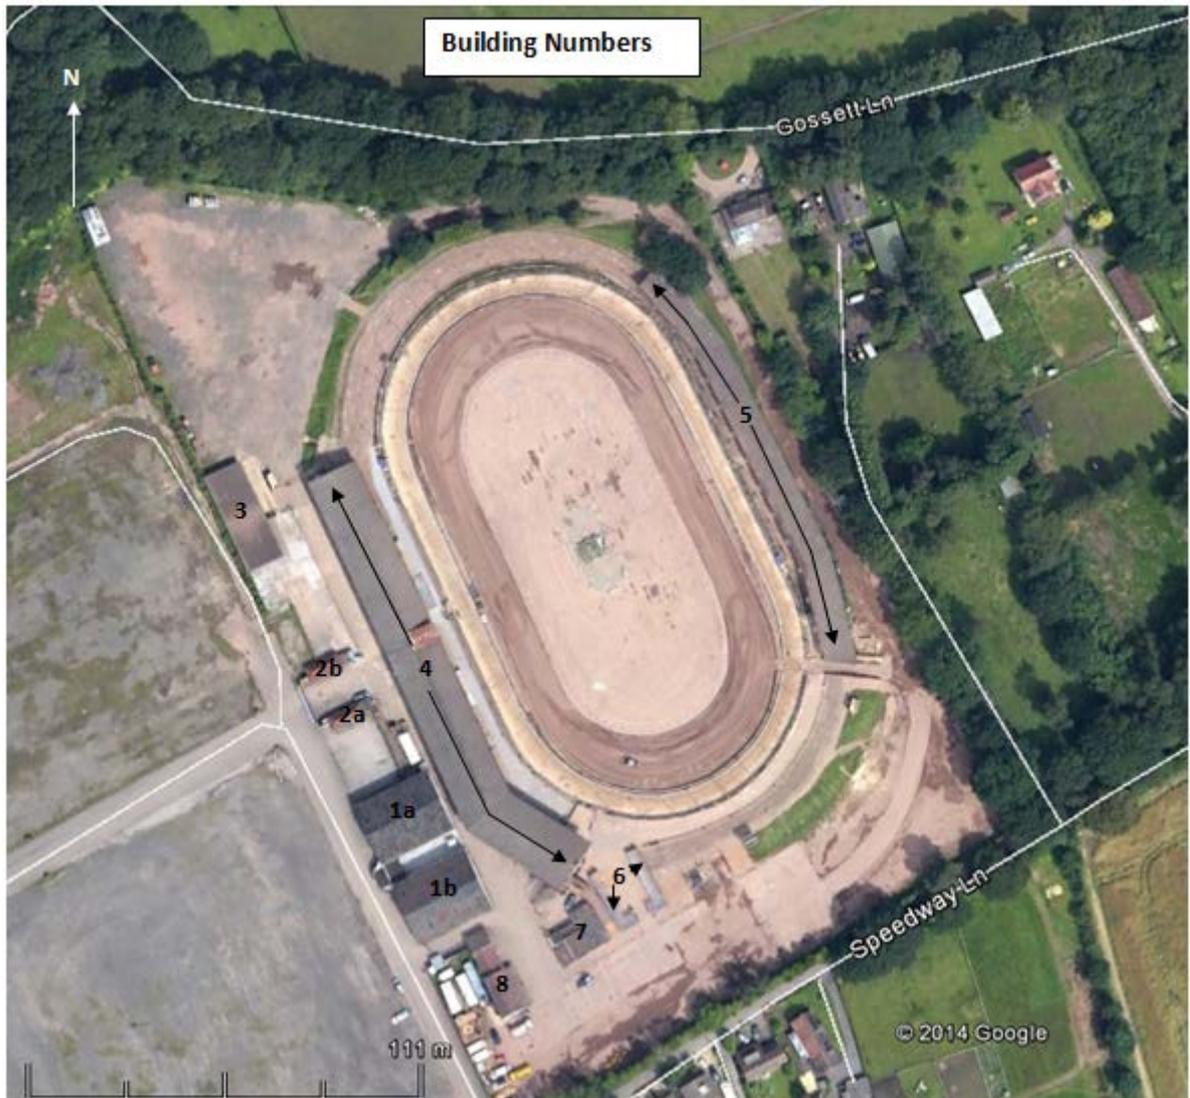
For ease of reference, each building was given a number, indicated on the following map, and is described below in detail.

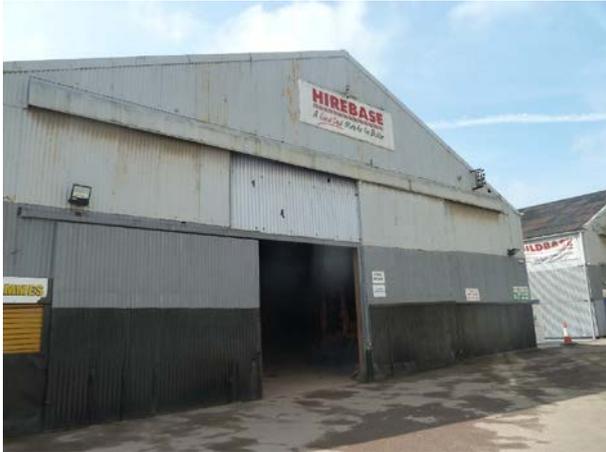
This building comprised two discrete areas 1a and 1b linked by the existing turnstiles. Each hangar building was at least two-storey high and neither had a separate roof void. They were steel-framed with a pitched roof of corrugated steel with roof lights and were, in part, clad with blockwork. Building 1a benefited from some deteriorating linen cloth stretched across the eaves creating a makeshift roof void (presumably to prevent pigeon, and the like, from nesting) whilst building 1b was fully vaulted, although this building did have some dividing walls creating separate cells and some areas of the building were, therefore, darker than others.

*Building 1a - eastern external elevation*

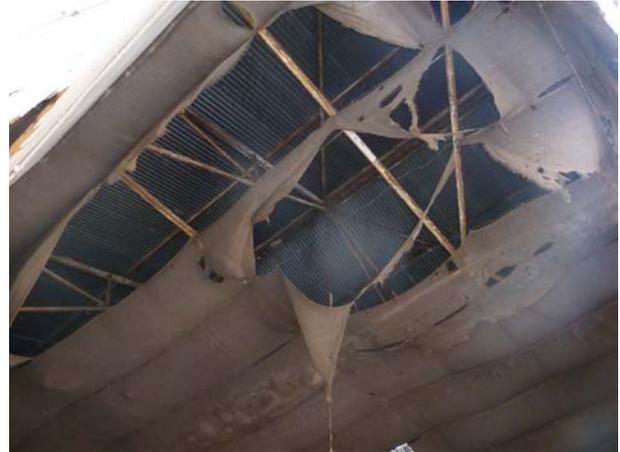
*Building 1a - internal*

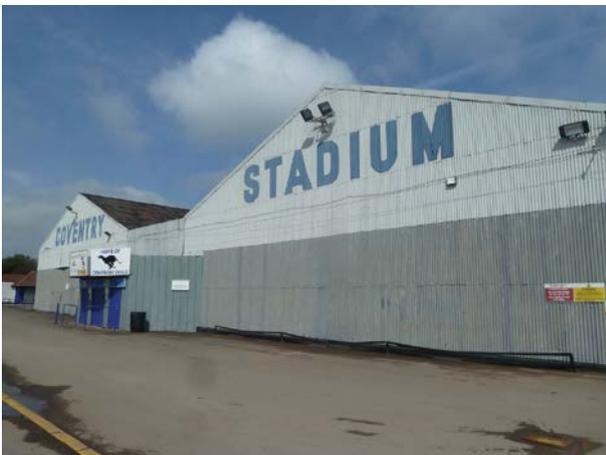
*Building 1a and 1b -western external elevation*

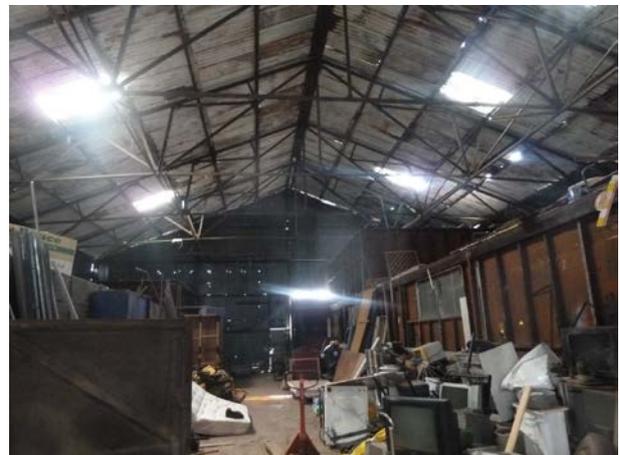
*Building 1b - internal*

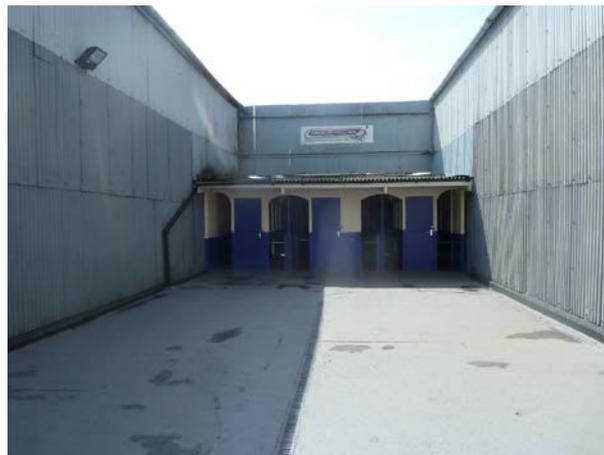
The turnstiles were open to their eastern elevation with a mono-pitch roof and a flat roof beyond this. Internally, a suspended ceiling was present beneath the flat roof, presumably resulting in a void between the ceiling tiles and the flat roof above of c0.5m high.

*Turnstiles between 1a and 1b*

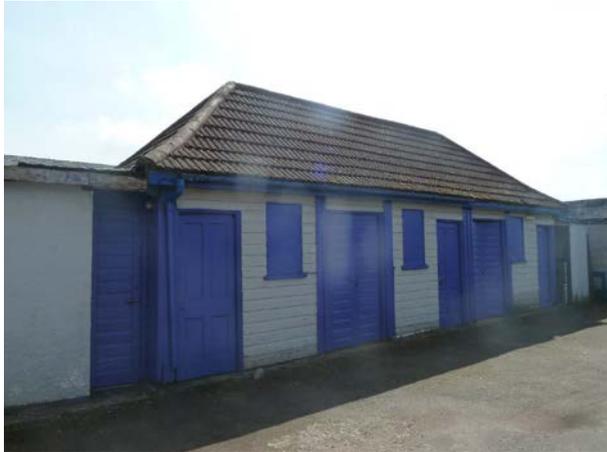
This comprised the former turnstyle buildings, of which there were two: 2a and 2b. These were small single-storey structures, each with a separate roof void. 2a was timber clad whilst 2b was constructed in blockwork and both had a hipped roof finished with interlocking tiles. In 2a, the loft hatch was open but access to this area by the surveyor, was hindered by the presence of stored barrels, although a roof underlining of bituminous felt was visible and appeared to be torn in places. In 2b, the roof void was accessible and was of a traditional purlin and rafter construction but with an underfelt to the roof of black plastic. The height of the roof void was c1m from ceiling to ridgeboard.

*Building 2a - northern elevation*

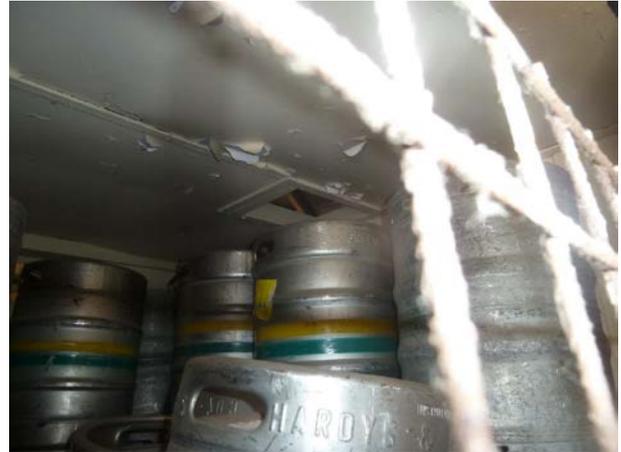
*Building 2a - internal; access to loft hatch was hindered*

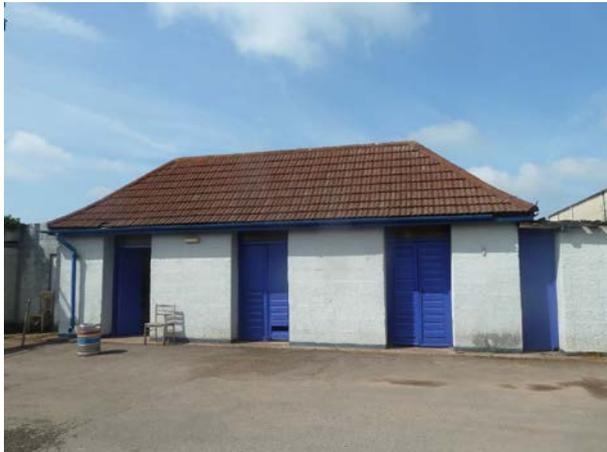
*Building 2b - southern elevation*

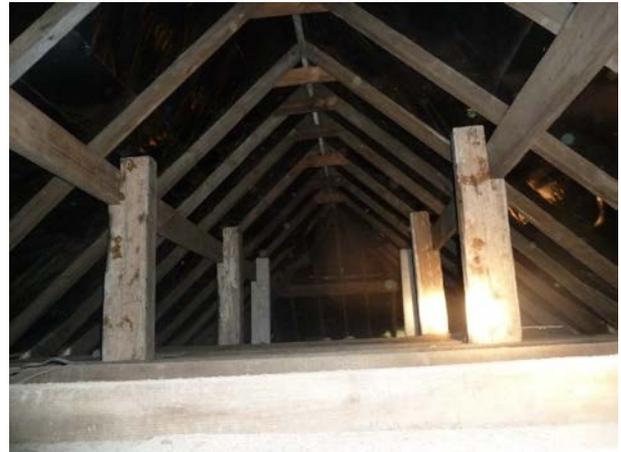
*Building 2b - roof space*

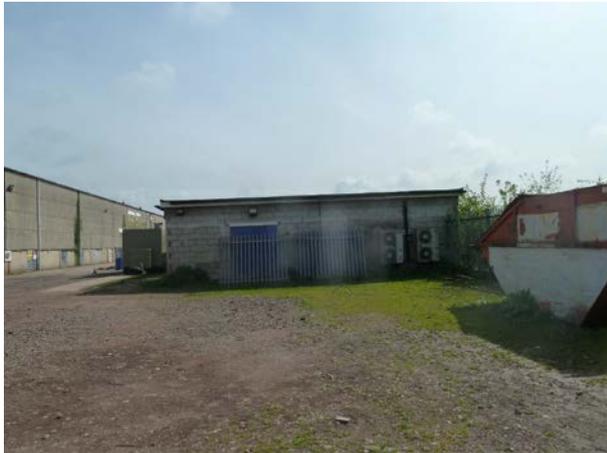
This comprised a large single-storey building that was in use as holding kennels for greyhounds during the race days. It was constructed in blockwork and was partly timber-clad. Its shallow pitched roof appeared to be finished with bituminous felt and internally a suspended ceiling meant no access to any roof void for the surveyor. However, removal of a ceiling tile revealed wooden sarking to the underside of the roof and a maximum height of roof void of 0.4m.

*Building 3 - southern elevation*

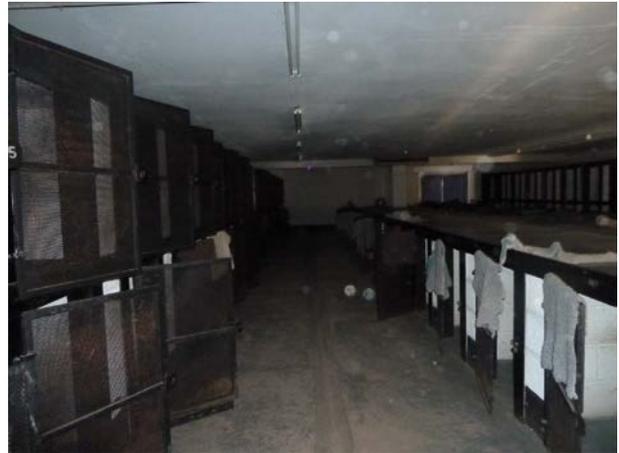
*Building 3 - internal*

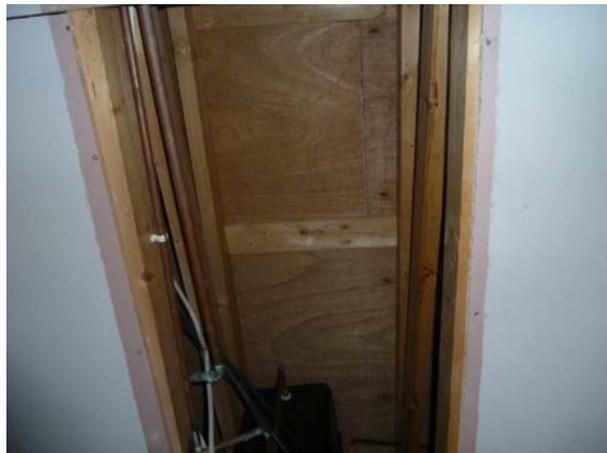
*Building 3 - sarking visible to underside of roof*

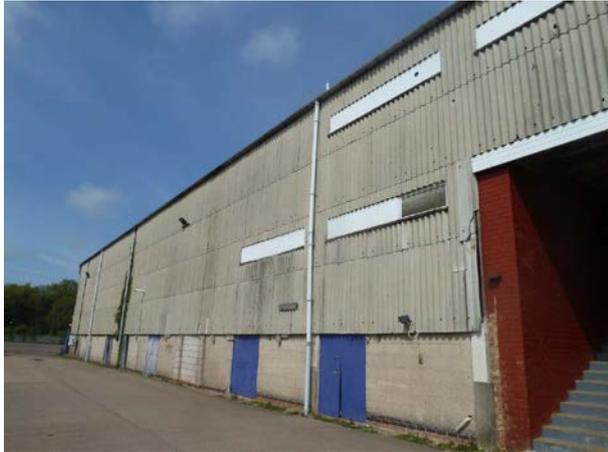
This comprised the main grandstand as well as the 'under stand'. The grandstand was an area of covered terraced steps with an enclosed glass viewing box area with a flat roof and walls of asbestos cement sheeting. The lean-to roof over all of this was supported by a steel frame and finished with corrugated sheeting. The 'under stand' area was located beneath the terraced steps and was an enclosed room (housing seating and places to eat). It was constructed in part brickwork and part blockwork and had a blockwork ceiling and no windows. To access the main grandstand there were steps leading into corridors at the western elevation of building 3. These corridors were constructed in brickwork but with a blockwork ceiling.

*Building 4 - western elevation and stairs leading to corridor*

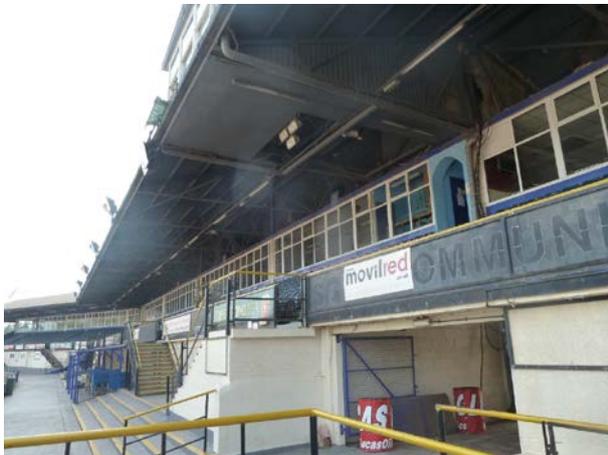
*Building 4 - eastern elevation showing terraced steps and under stand below*

Building 4 appeared, at the time of the initial bat inspection, unlikely to support summer roosts of bats as the potential roosting areas were largely in shade but this building was considered to offer medium hibernation roost opportunities for bats during the winter months. Due to the potential extent of the cavities within the ceilings, it is not considered possible to carry out hibernation checks of the building with any degree of confidence, although a check for bats in winter is recommended, it should be noted that an absence of bat evidence at this time would not necessarily represent an absence of bats. As such, it is assumed that such a building could house hibernating bats and a replacement hibernation building is recommended to be erected within the shaded woodland area. Further details and sensitive working practices are described in the sections below.

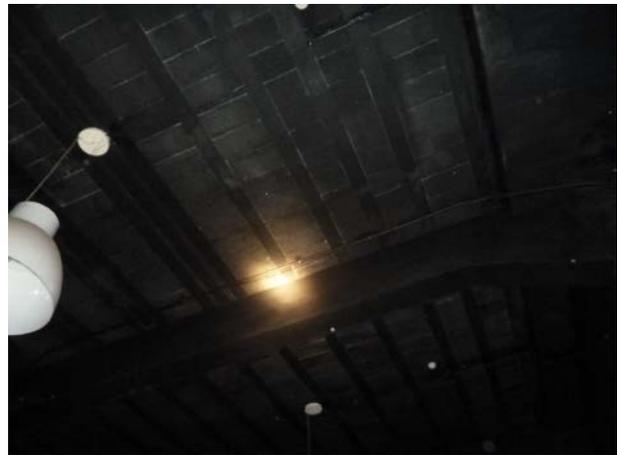
*Building 4 - view of ceiling in the under stand*

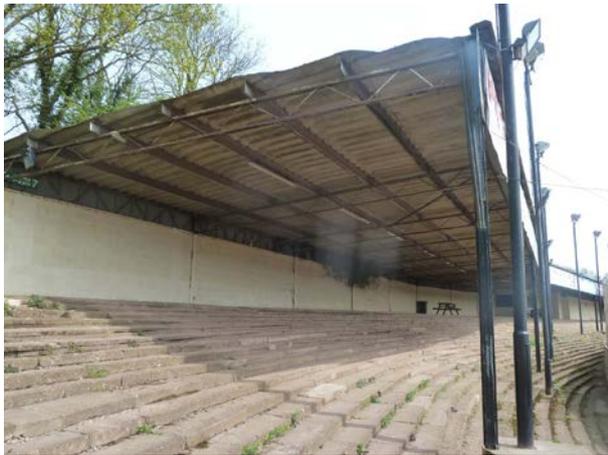
This comprised the other covered terraced steps opposite the grandstand on the opposite side of the race track. A part timber and part steel-framed structure supported a lean-to roof of corrugated sheeting, whilst blockwork cells housed separate male and female toilets. A plasterboard ceiling was present on top of the blockwork (and below the lean-to roof over the terrace) over the cubicles such that no roof void was present in this area, although in the area adjacent to the toilets, no ceiling was present, although fascia boards were present against internal blockwork walls.

*Building 5 - viewed looking south*

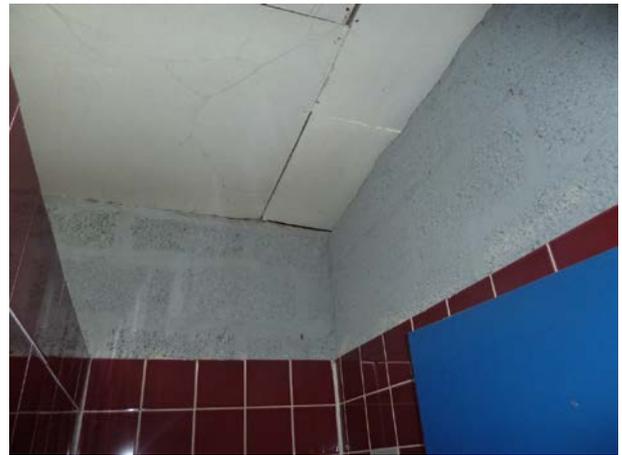
*Building 5 - internal; ceiling in toilet cubicles*

At the end of the survey, Anna Swift investigated the doorway where a common pipistrelle had been noted and a single common pipistrelle flew out from on top of the wall where it had been roosting. The same surveyor then entered the ladies toilet block adjacent to this doorway and under the grandstand and three further common pipistrelle were seen to fly out of this area. A closer inspection of the area where the bats had been disturbed revealed a small amount of fresh bat droppings stuck to the inside wall of the ladies toilet block. It appeared that the bats were roosting on top of the blockwork wall in a gap between the wall and the roof covering and that a total of four individuals were roosting there at the time of survey. The surveyor quickly retreated to minimise disturbance once a bat dropping had been collected from this area. DNA testing of the bat dropping revealed a maximum likelihood of common pipistrelle *Pipistrellus pipistrellus* which confirmed the results of the dawn activity survey.

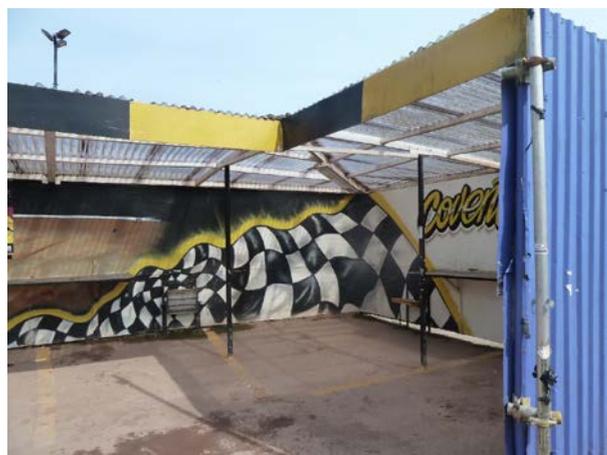
This comprised an area of single storey, lean-to perspex and corrugated buildings with steel frames for cycle storage or similar.

*Building 6 - cycle storage*

The open sided nature of this building together with the unsuitable roof structure of perspex sheeting would result in conditions that were too light and draughty to support roosting bats and the likelihood of this is considered to be LOW.

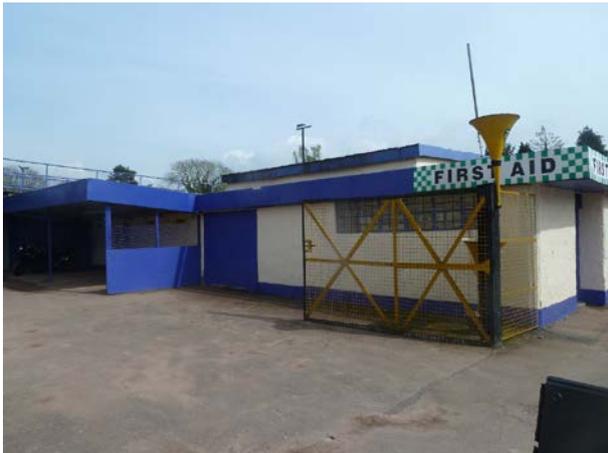
This comprised an office unit and first aid station and was only accessible in part to the surveyor at the time of survey. It was constructed in solid brickwork with a flat corrugated roof and its roof height was greater in the central area of the building. Internally, there was a plasterboard ceiling with no accessible roof void. Any void was likely to only comprise the depth of the rafters.

*Building 7 - north elevation*

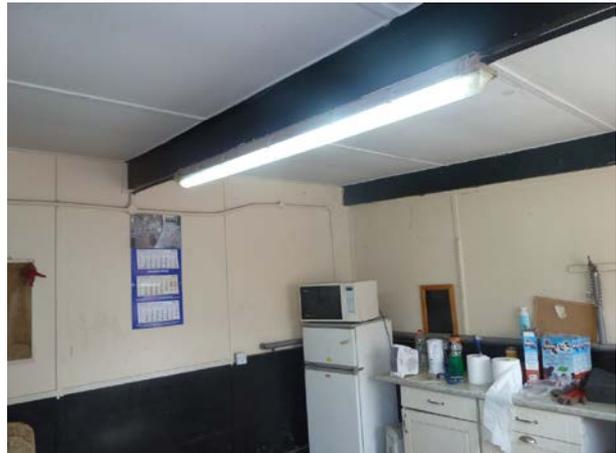
*Building 7 - internal*

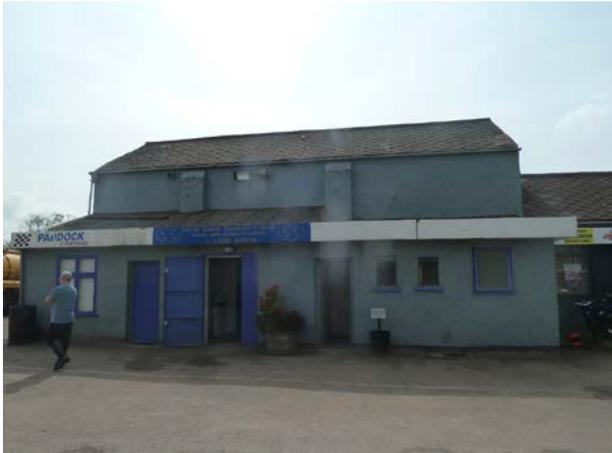
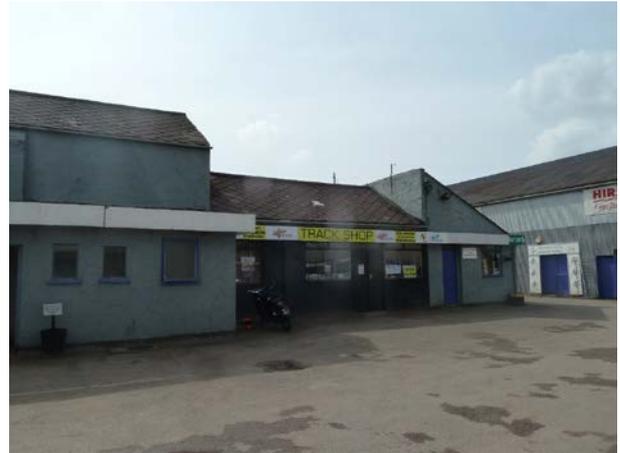
Building 8b housed a bike shop, again with no access to the upper floor/roof void, although the roof line of this building was subservient to Building 8a.

*Building 8 - a, b, c from left to right*

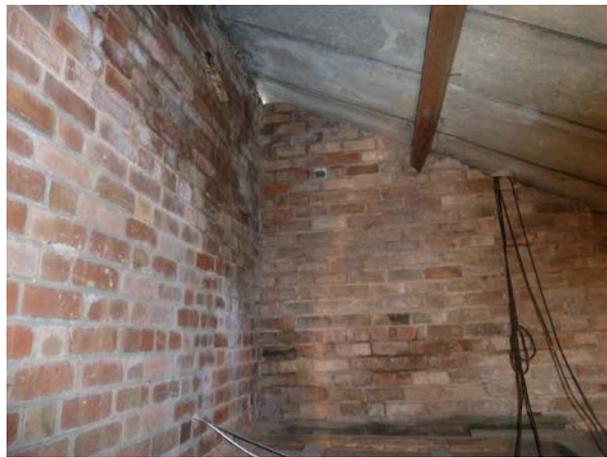
Building 8c was used as storage and access was gained via a loft hatch to the roof void above. The roof of this building was mono-pitched and timber rafters were present but with no wooden sarking or felt present to the underside of the roof. No insulation was present at ceiling level or between the rafters and the maximum headroom within the void was c1.6m where it joined building 8b.

*Building 8c - roof void*

Within the roof void of building 8c (with the monopitch roof) a single bat dropping, which appeared to have been deposited no more recently than the past 12 months, was noted on the floor of the roof void below a rafter together with a discarded butterfly wing (the latter could be evidence of spider activity or perhaps food remains from a brown long-eared bat).

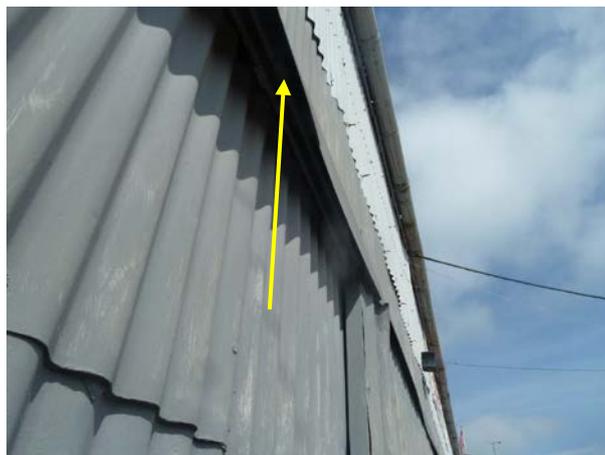
Bats could potentially have gained access anywhere at eaves level as there was a significant gap between the lip of the roof and the walls as indicated by the photograph below. Once inside the building, the steel frame was unlikely to lend itself well to roosting bats as its surface is too smooth to cling to, whilst the corrugated sheet metal roof would likely heat and cool quickly and would not offer a stable temperature for roosting bats. Roosting opportunities were considered to be limited to the tops of the blockwork walls. Likelihood of roosting bats in this building was LOW.

*Building 1 - typical access point for bats*

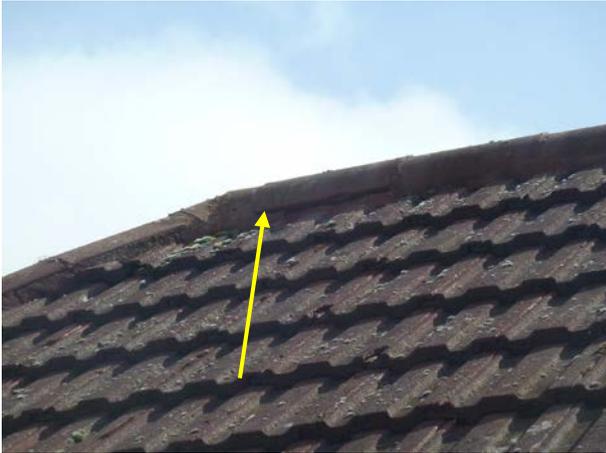
Typical access into either building 2a or 2b was via occasional gaps under tiles or at the eaves, as illustrated by the photographs below. It is likely that this could gain crevice-dwelling bats access into the area between the tiles and the lining or perhaps on top of the ridgeboard. From here, if bats could access the roof void via a gap in the lining then there were opportunities to roost between the ridgeboard and the rafters as well as on top of the gable wall. The construction of the roof was suitable either for small, crevice-dwelling bats such as pipistrelle or for slightly larger void-seeking bats such as brown long-eared; however, this was tempered by the fact that these buildings were single-storey and were surrounded by hardstanding, which is likely to reduce the overall likelihood of roosting in these buildings to LOW-MEDIUM.

*Building 2a - typical access point for bats*

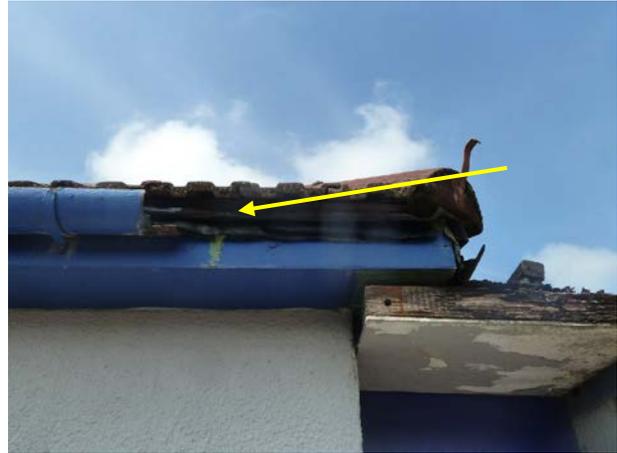
*Building 2b - typical access point for bats*

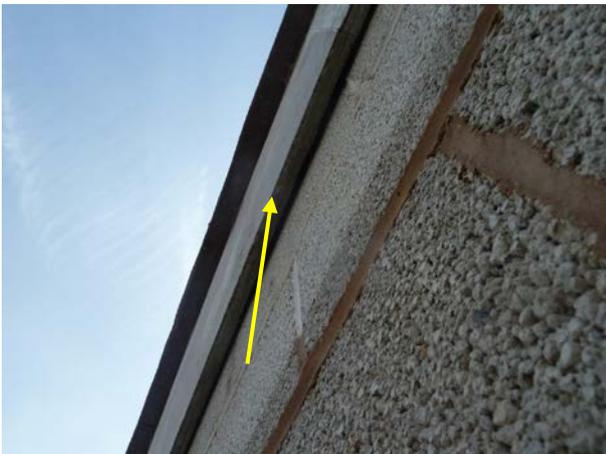
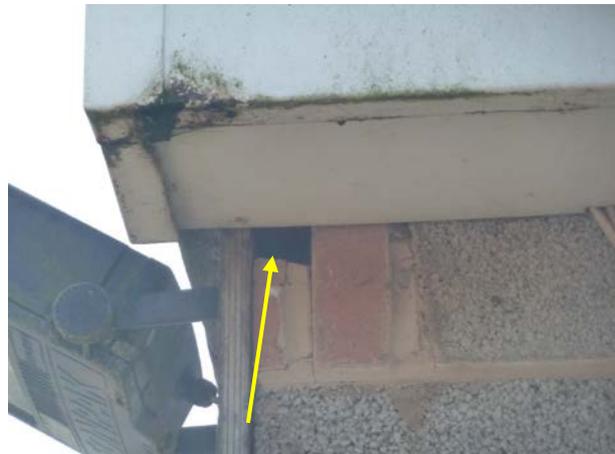
Typical access into this building was at damaged soffits or behind fascias, as illustrated by the photographs below. It is likely that this could gain crevice-dwelling bats access into small gaps within the soffit or behind the fascia board (both areas favoured by pipistrelle). It may also be possible to access the roof void from these areas, however this was so small and had such a shallow pitch that it could only be suitable for use by pipistrelle (or similar) and was unsuitable for use by void-seeking bats such as brown long-eared. Overall the likelihood of roosting in this building was LOW-MEDIUM for crevice-dwelling bats only.

*Building 3 - typical access points for bats at soffit and fascia*

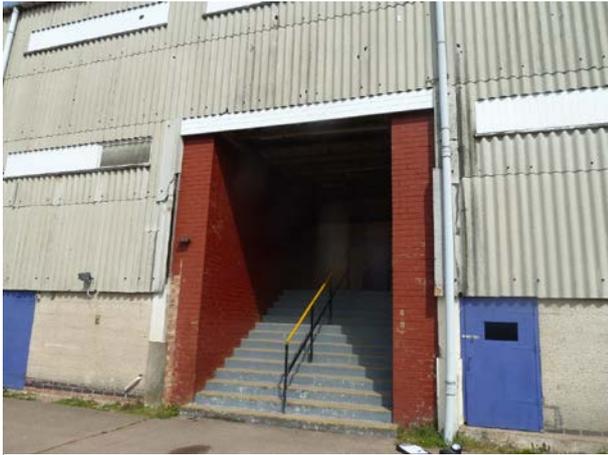
Typical access into this building was present via the open stairways which provided access for bats to roost between the gaps in the ceilings and possibly into any void that may have been present at ceiling level. As these corridors were shaded by the rest of the grandstand, it was more likely that these areas could be used by roosting bats during the winter months, as a hibernation site. This potential was considered to be MEDIUM, given the presence of the ancient woodland nearby which is likely to support summer roosts of bats and represent a significant foraging resource in the locality. Ceilings such as this, were present above corridors, in the 'under stand' area and within storage cells at ground level adjacent to stairways on the western elevation - and access for bats, was possible into all of these areas, as illustrated by the photographs below.

*Building 4 - typical access for bats via open stairway*

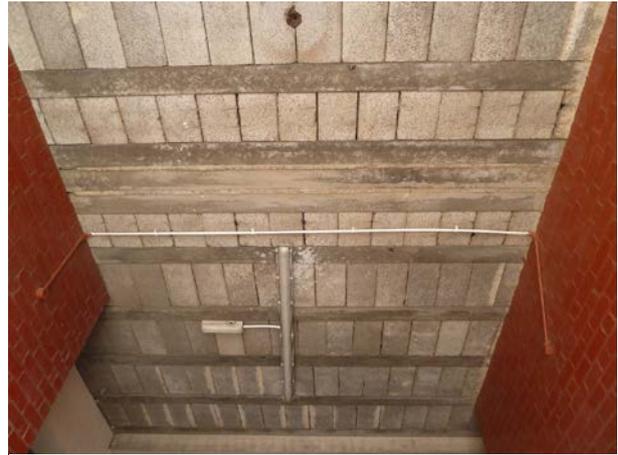
*Building 4 - ceiling providing roosting opportunities for bats*

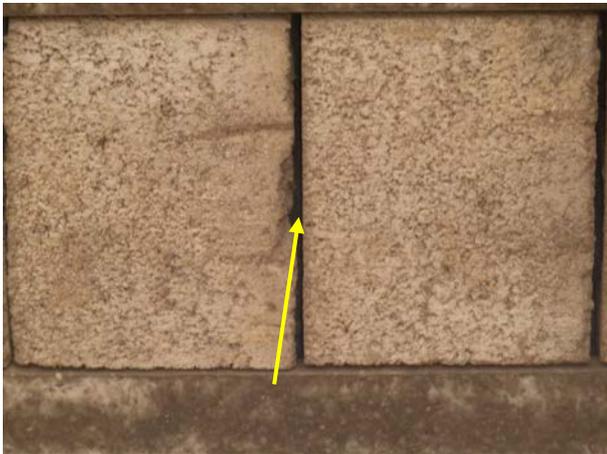
*Building 4 - winter bat roosting opportunity in ceiling*

- Following completion of the survey, as there is the potential for hibernating bats within building 4, it is recommended that **1-2 checks between January and February** (typical time of peak hibernation numbers) are undertaken using the most appropriate methodology whilst minimising disturbance. Appropriate methodology may include use of static bat detectors or detailed investigations with a torch or endoscope. The results of this further check, if positive, would inform the detail of the bat hibernacula as well as a possible licence application to Natural England, but should no evidence of bats be noted, this does not equate to an absence of bats and the bat hibernacula as designed for general use by bats (see overleaf), should be erected prior to any disturbing works to building 4.

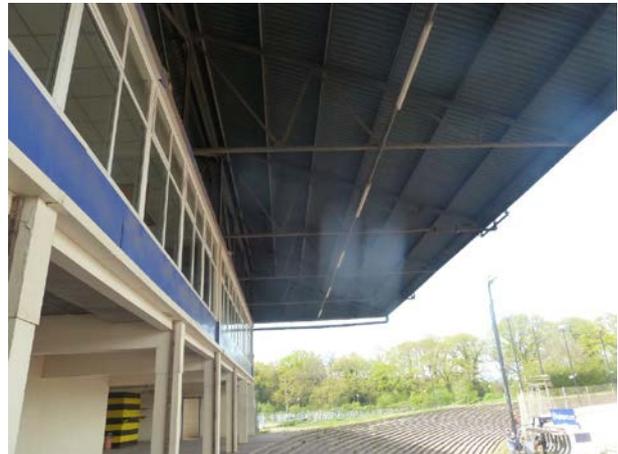
*Building 4 - sub-optimal roof structure of grandstand*

The main roof of the grandstand had a similar construction as Building 1 and in this area only, bat roosting was considered to be LOW.

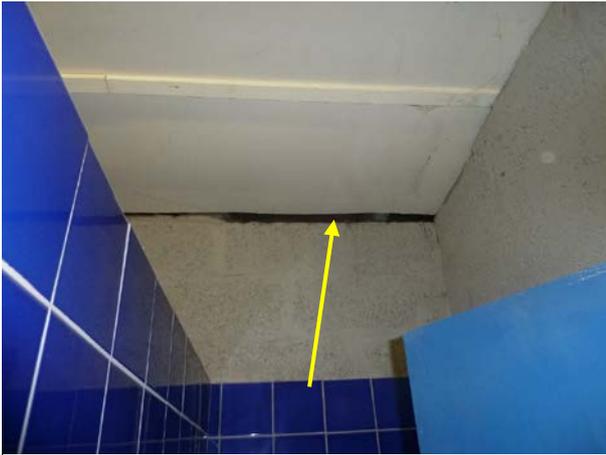
There were blockwork cells creating separate male and female toilets, which were freely accessible to bats. Roosting opportunities were present on top of blockwork walls where a ceiling was present or possibly behind the fascia board on the blockwork - such areas favoured by pipistrelle bats. Typically such a building would offer only low potential for roosting bats but as this building is adjacent to a line of trees and some cover, this is elevated to LOW-MEDIUM potential for roosting bats.

*Building 5 - roosting opportunity in ceiling/on top of blockwork wall*

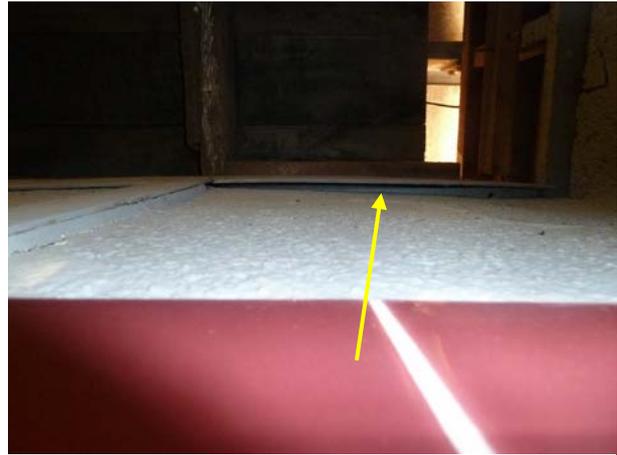
*Building 5 - roosting opportunity behind fascia board*

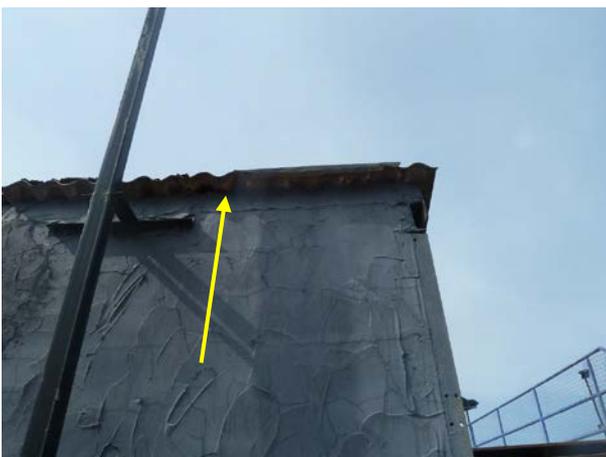
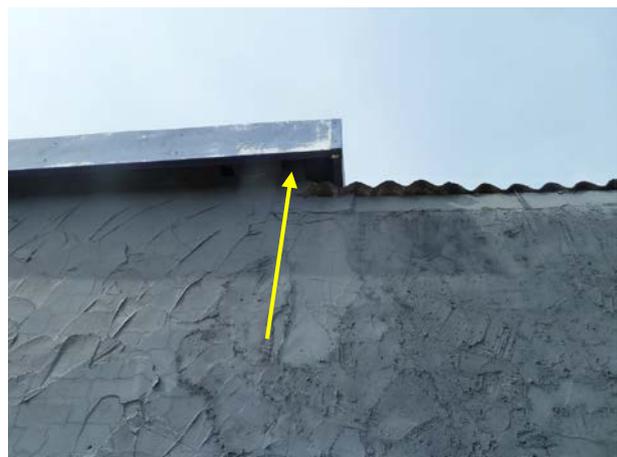
Typical access into this building was via gaps at the eaves where the corrugated metal roof sheets slightly overhung the walls. The construction of the roof did not lend itself to sustained roosting by bats (likely due to fluctuations in temperature) although roosting opportunities may have been present for crevice-dwelling bats on top of the walls or in the depth of the ceiling joists. Overall, the likelihood of roosting in this building was LOW-MEDIUM for crevice-dwelling bats only.

*Building 7 - typical access points for bats*

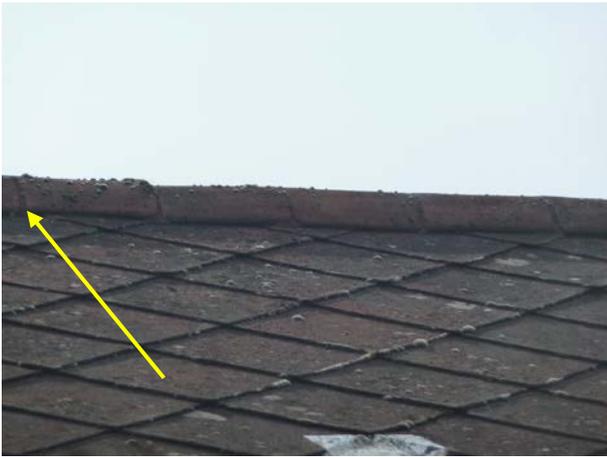
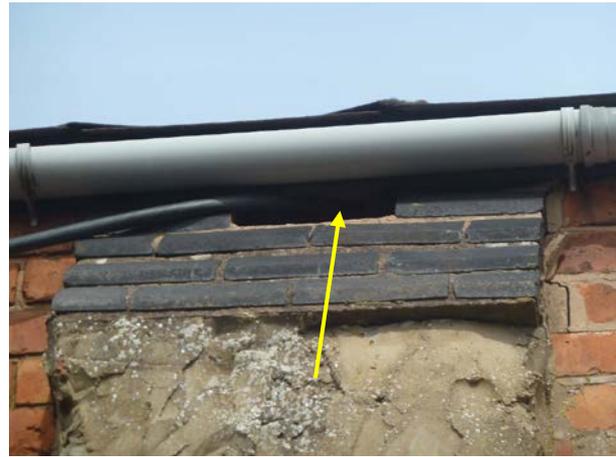
Typical access into this building was via gaps at the eaves where there were gaps at brickwork, via gaps at gable verges where mortar had spalled as well as under ridge tiles, as illustrated by the photos below. Access into roof spaces of all three voids of building 8 appeared possible for bats, although the construction of the roofs of sections a and b of this building was unknown. Nevertheless, assuming a ceiling at eaves height and an uncluttered void (as such buildings appear to be constructed pre 1980's), it was likely that such roof spaces were suitable for use by crevice-dwelling and void-seeking bats. The roof void of 8c was accessed and whilst its roof was only monopitch and the resultant headroom was limited in places, it still appeared suitable for both types of bats with roosting opportunities at timber junctions and on top of the wall where it joins 8b. Overall, the likelihood of bats roosting in this building group was MEDIUM.

*Building 8 - typical access points for bats*

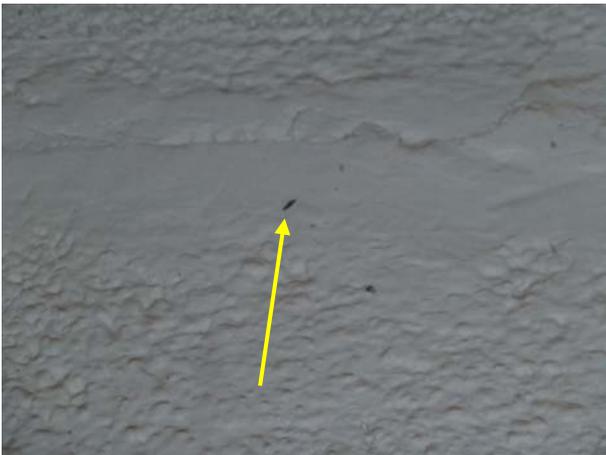
A close inspection of the toilet areas within building 5 revealed a possible bat dropping stuck to one of the inside blockwork walls below the gap at the fascia board. This droppings crumbled to the touch and it was not possible to send it for DNA analysis.

*Building 5 - possible bat dropping stuck to wall within the toilet area*

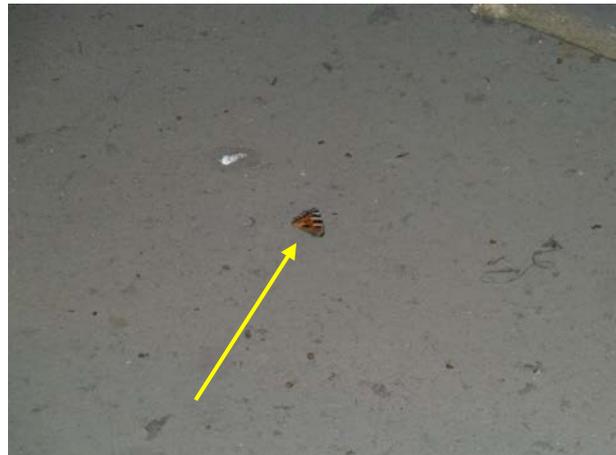
*Building 8c - discarded butterfly wing within the roof void*

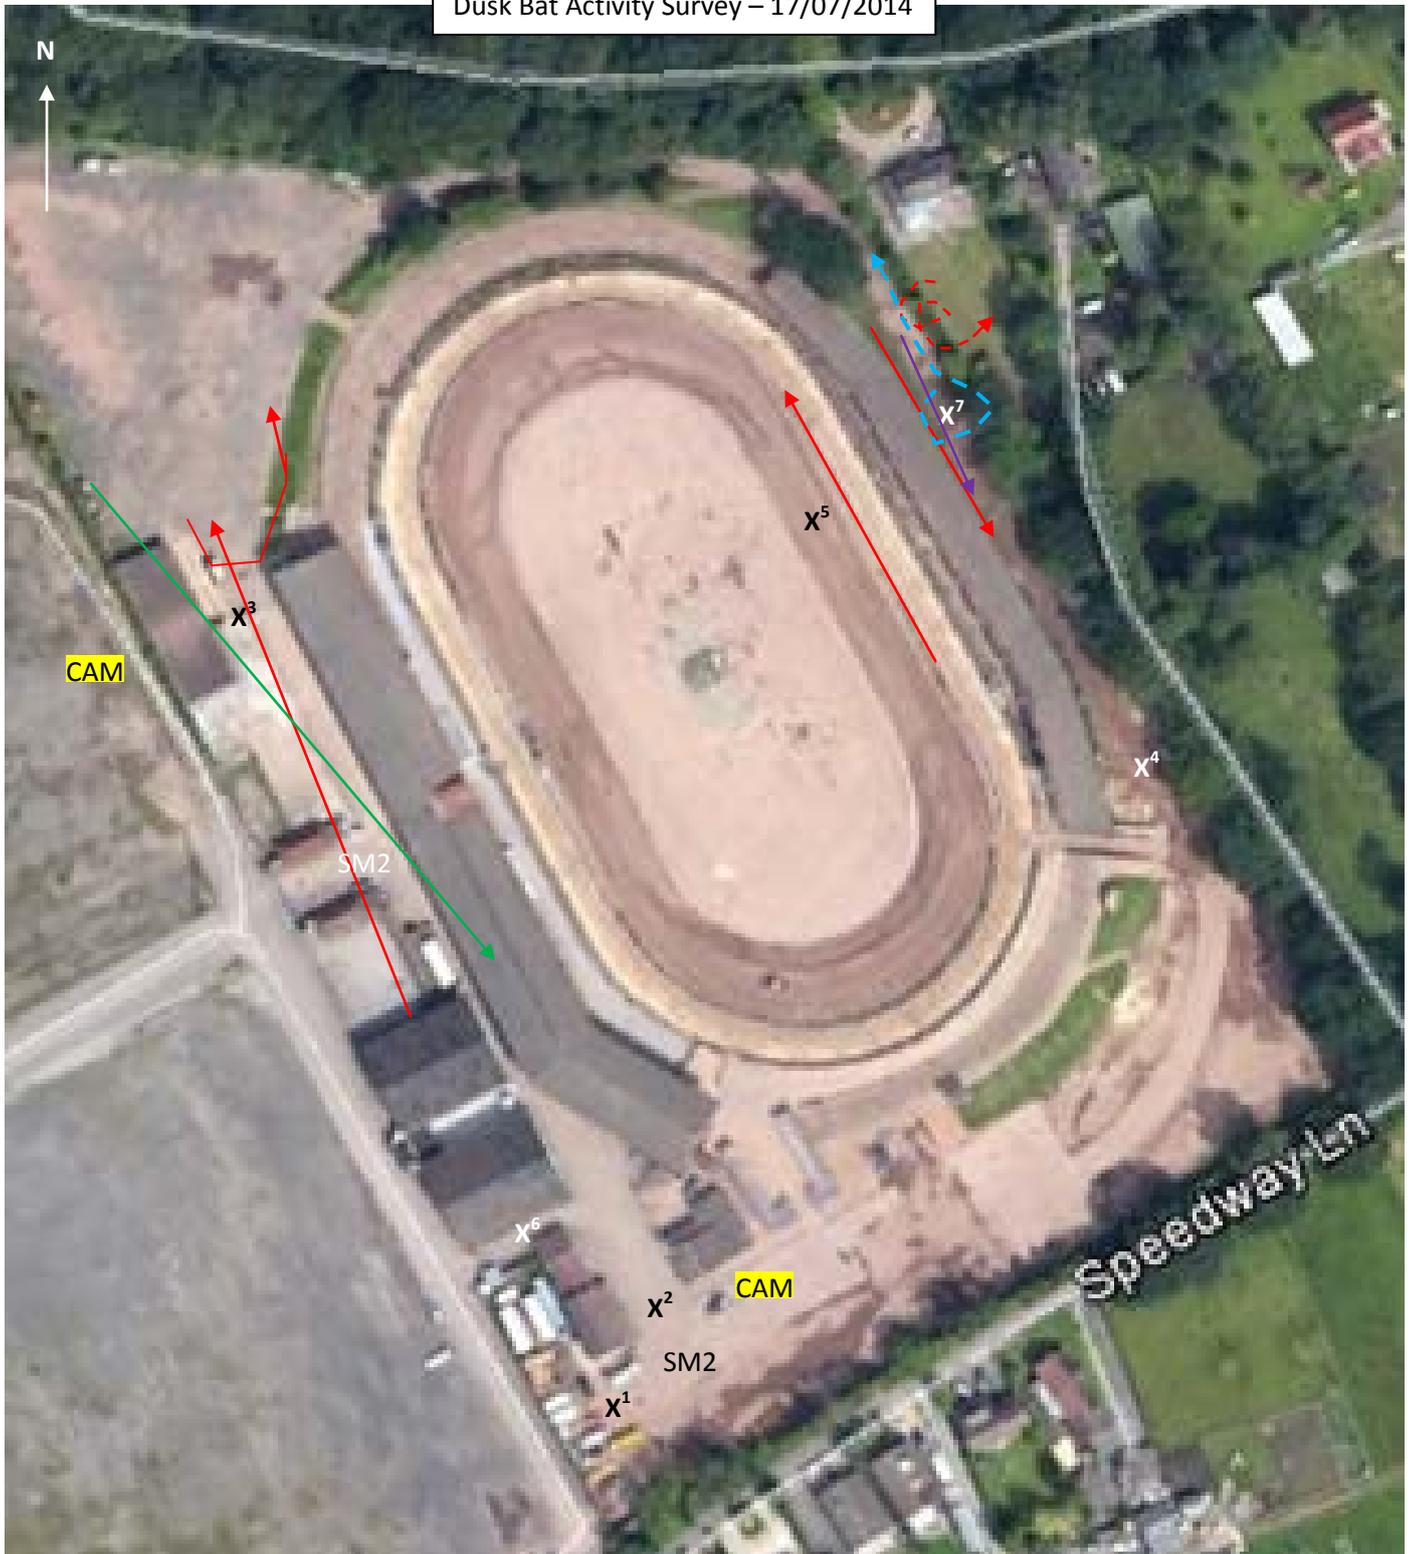
Dusk Bat Activity Survey – 17/07/2014

During the dusk emergence survey on 17<sup>th</sup> July 2014, despite appropriate weather conditions and timing of the survey, no bat passes were detected by any of the surveyors around building 8. The camera located on building 7 detected one bat pass some 42 minutes after sunset but this bat did not emerge from the building. The camera on the western elevation of building 3 detected a total of three bat passes from 35-61 minutes after sunset, but none of these bats emerged from the building, instead they were flying close to the tree-lined fenced boundary north-west of building 3. Indeed, the surveyor positioned at building 3 recorded a good amount of bat activity along the northern boundary of the site along the woodland edge including passes by common pipistrelle and a *Myotis* species.

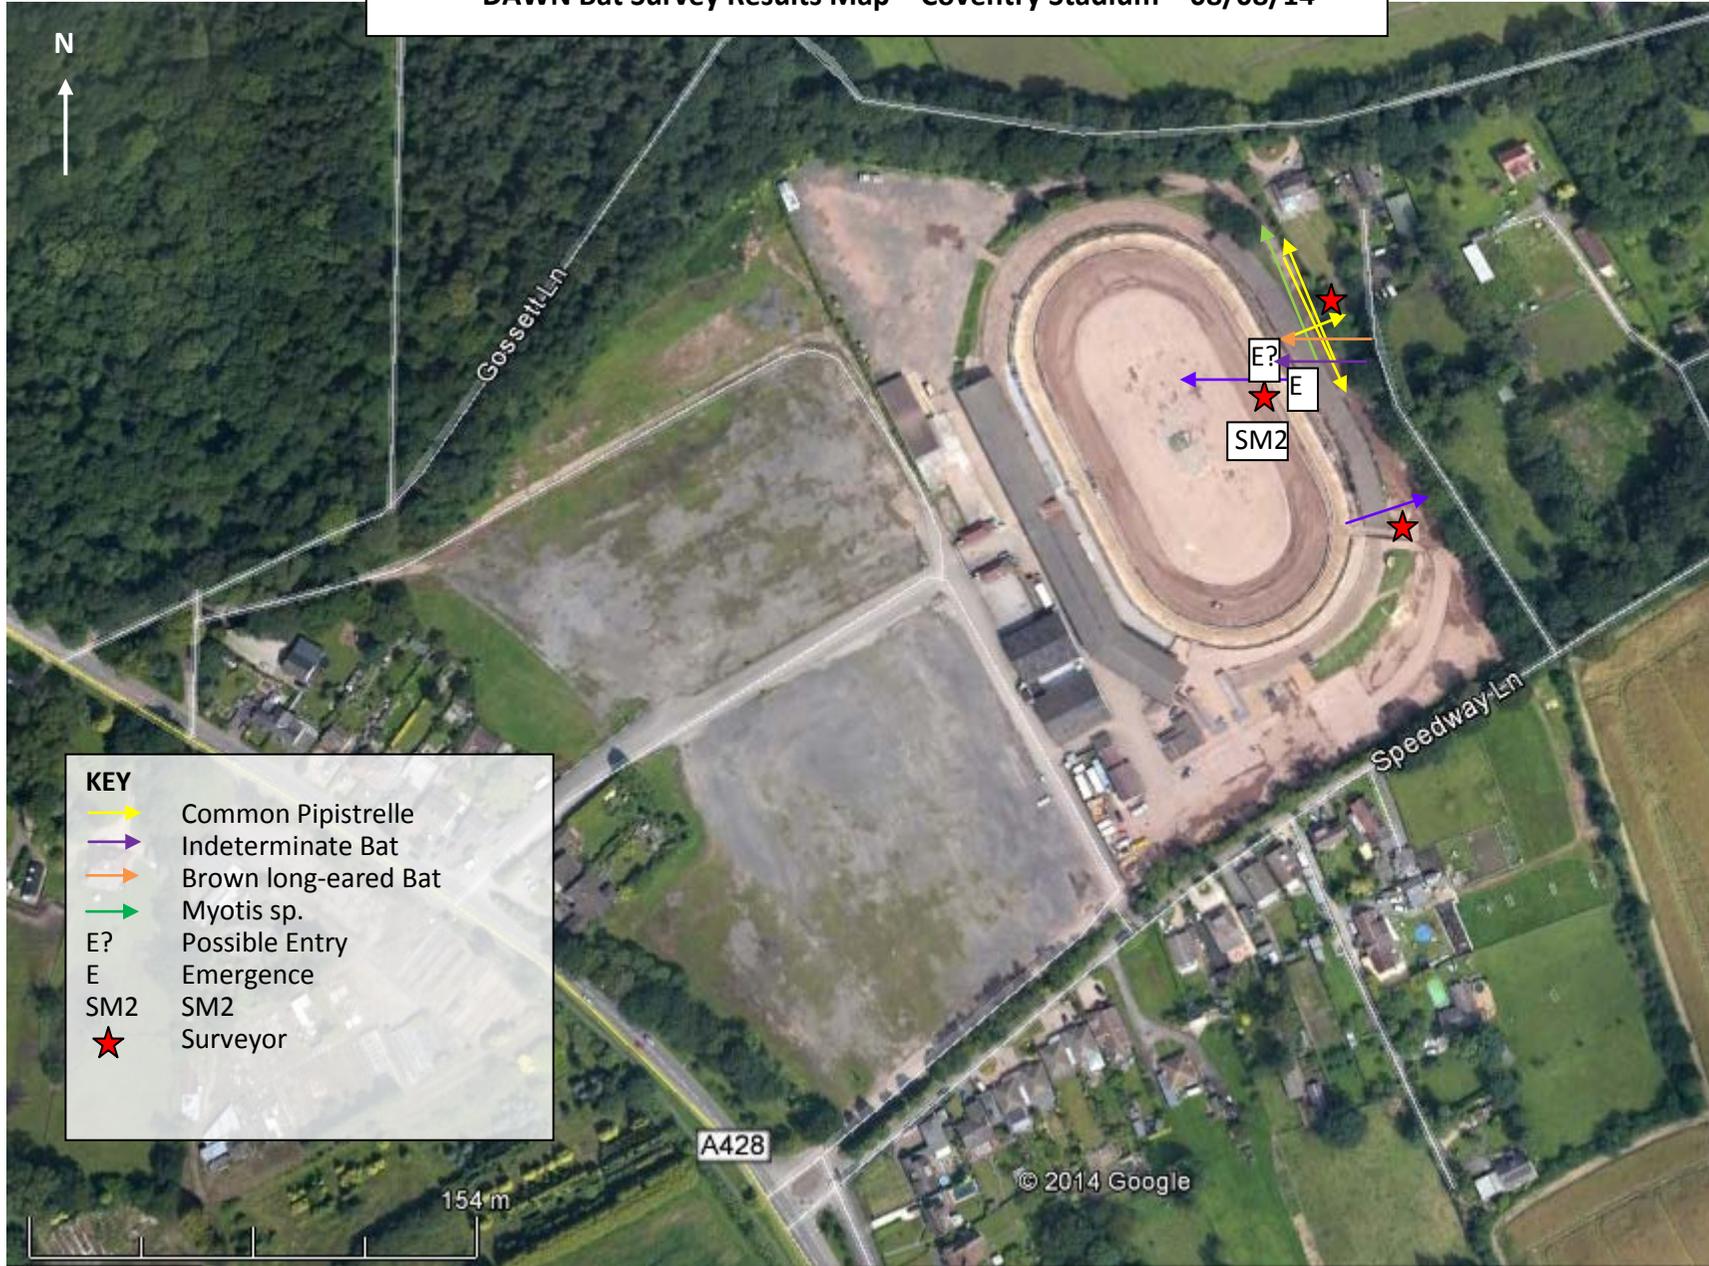
DAWN Bat Survey Results Map – Coventry Stadium – 08/08/14

During the dawn entry survey on 8<sup>th</sup> August 2014, much bat activity was noted along the eastern tree-lined boundary with foraging common pipistrelle and brown long-eared bat noted for much of the survey. Occasional passes by a brown long-eared bat and by common pipistrelle (through a doorway into the grandstand) were noted by surveyor 1, but then these bats were not seen again. It was possible that the common pipistrelle had entered the building. The other surveyors had occasional bat passes but no bats were seen to enter the building.
