# Bat Assessment Report

Coventry Stadium  
Rugby Road  
Coventry  
CV8 3GJ

Brandon Estates Ltd.

(13<sup>th</sup> October 2017 - REVISION B)

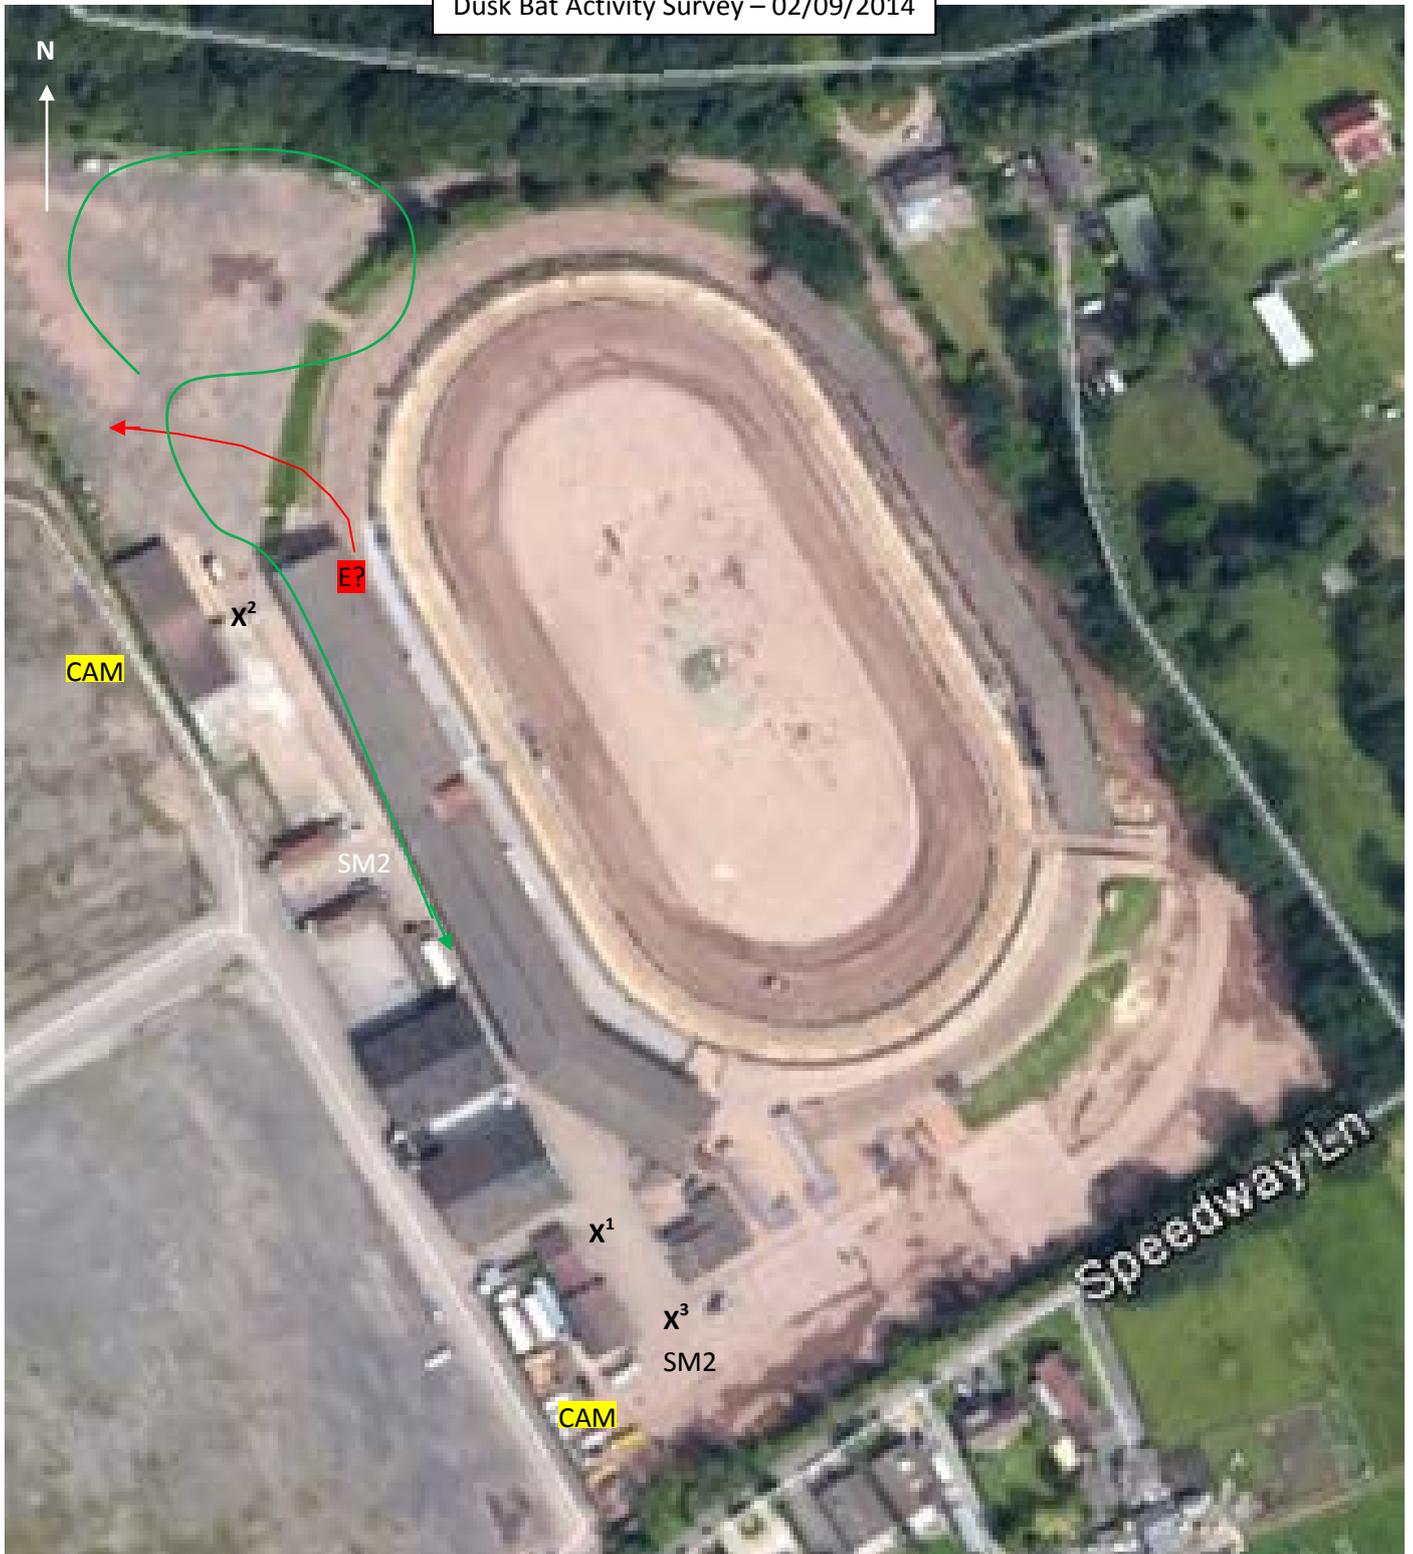
Dusk Bat Activity Survey – 02/09/2014

During the second dusk emergence survey at the site, a single common pipistrelle was considered likely to have emerged from building 4. Whilst the bat appeared from the eastern side of the grandstand and the surveyor could not see exactly where the bat had come from, there remained the possibility that the bat could have emerged from building 5 and flown across the track and close to building 4. The bat did not arrive from the south as it was not detected by the other surveyors or by the static bat detectors. The bat was noted some 20 minutes after sunset and this is well within the typical emergence time for this species.

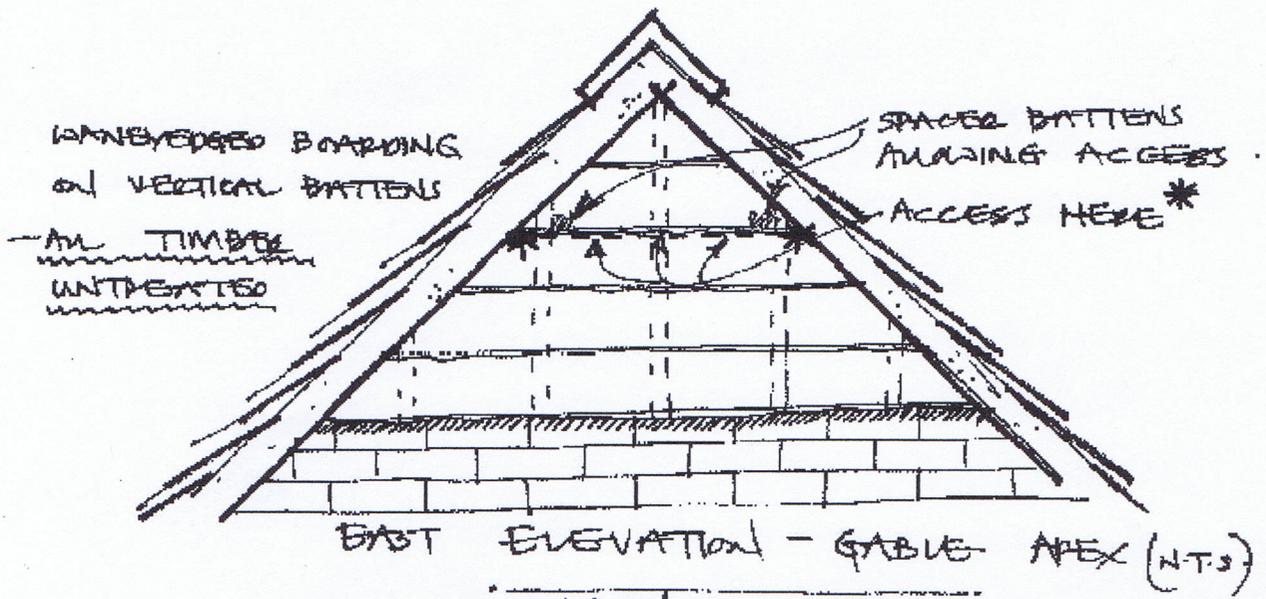
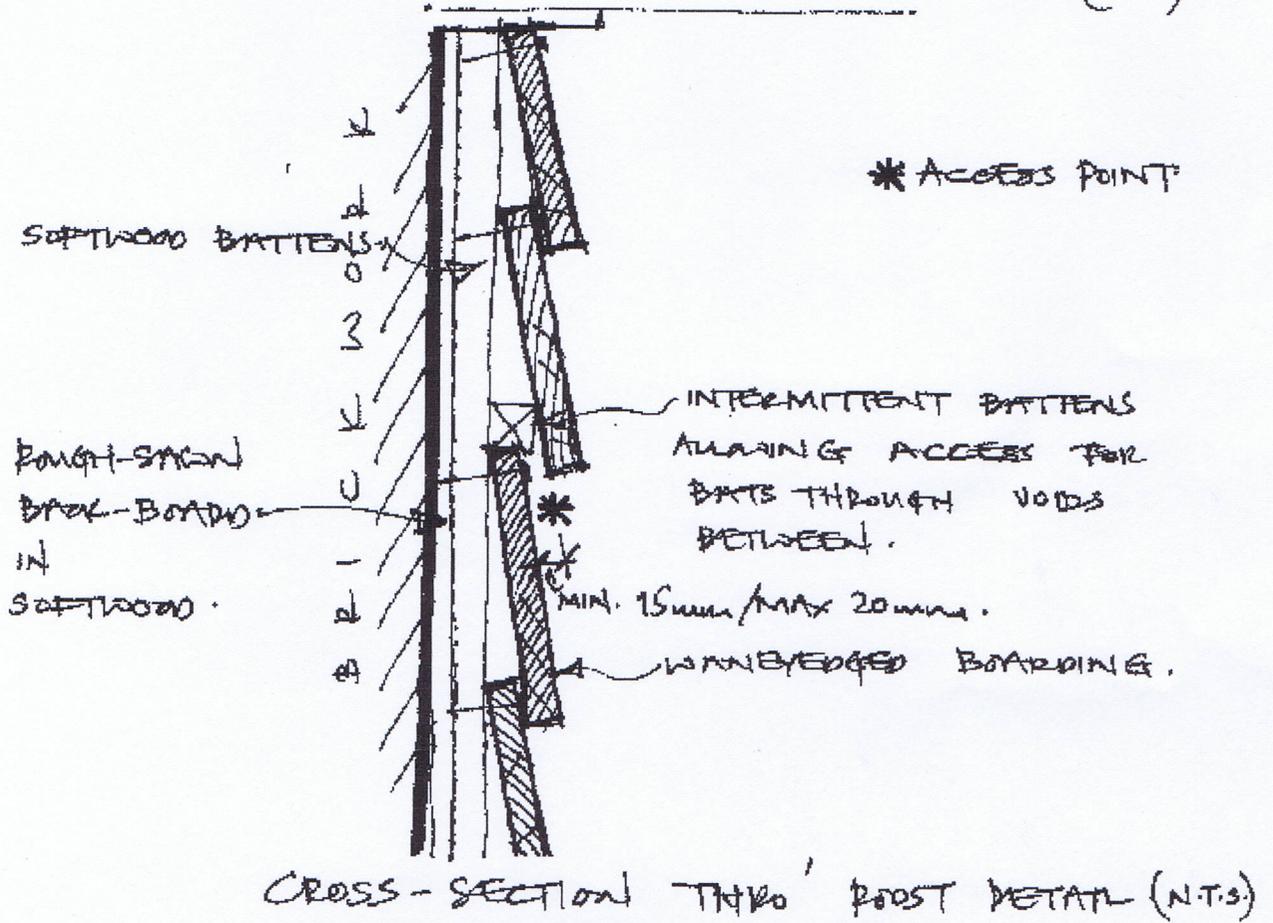
TIMBER CLADDING ROOST DETAIL FOR CREVICE-DWELLING BATS

- ❖ Replacement roosting opportunities for common pipistrelle to include the addition of timber cladding to the south-facing gable of a garage as well as the potential for access to the area under a ridge tile and on top of the ridgeboard.

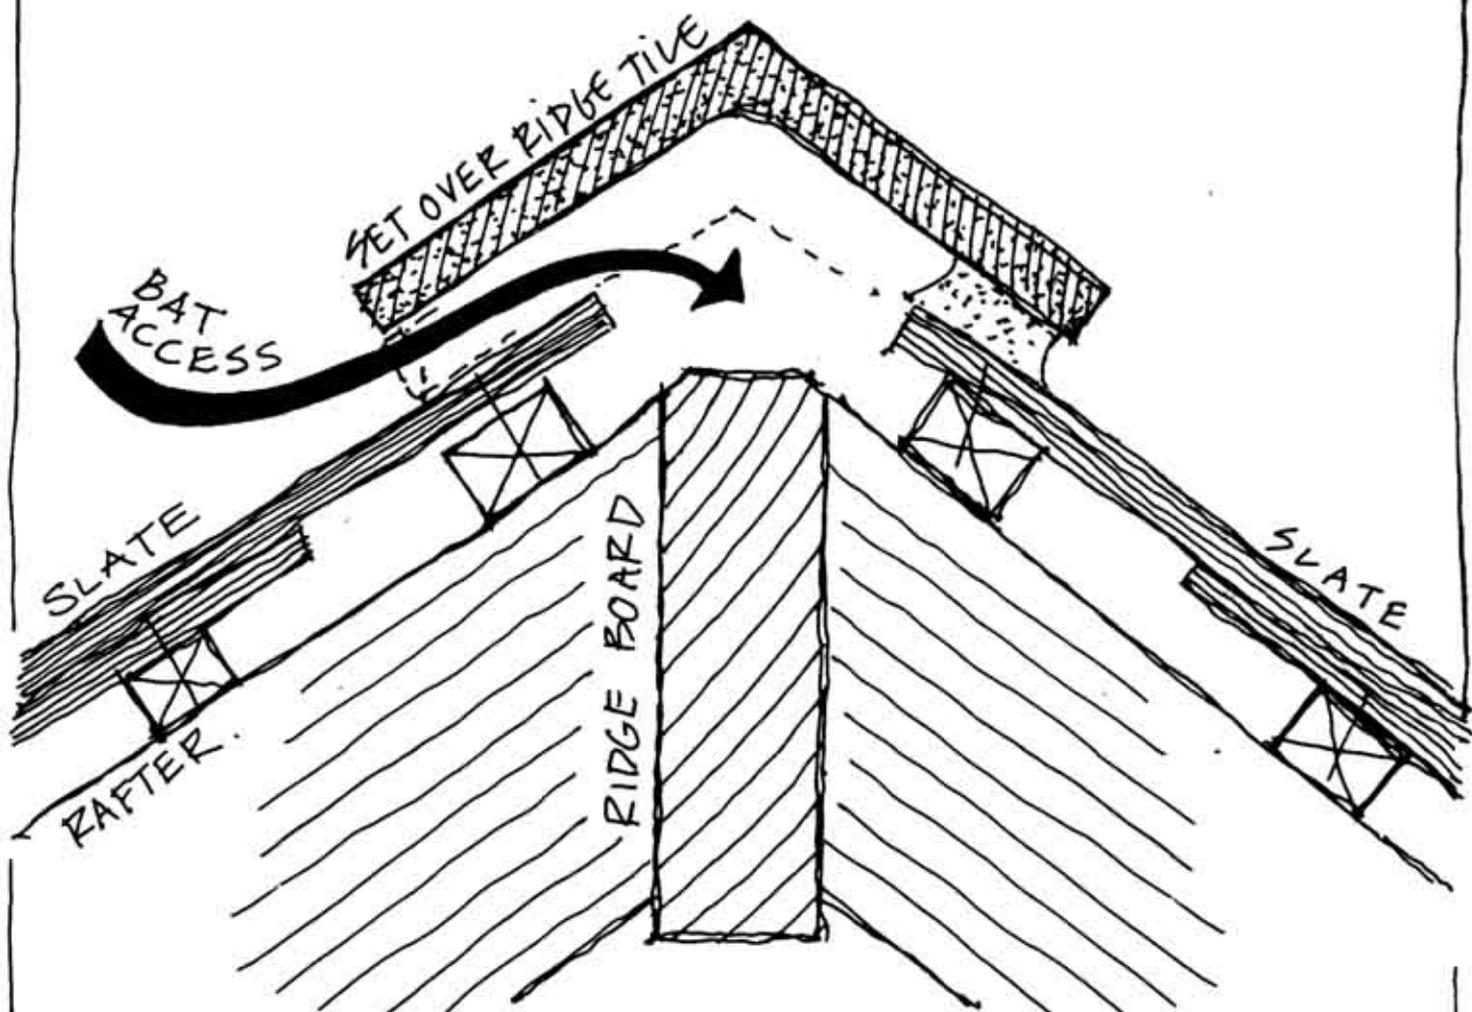
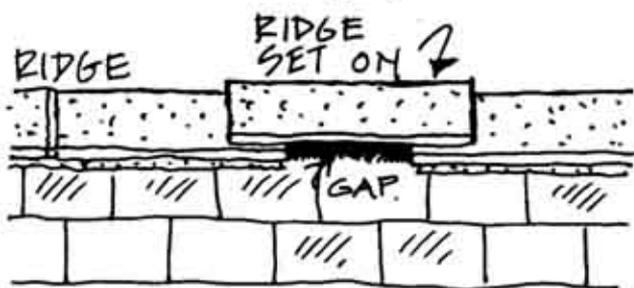
# RIDGE TILE ACCESS DETAIL 4A

~ OPTION A ~

ROOF RIDGE SET ON TOP OF GENERAL RIDGE TILES TO FORM BAT ACCESS GAP.

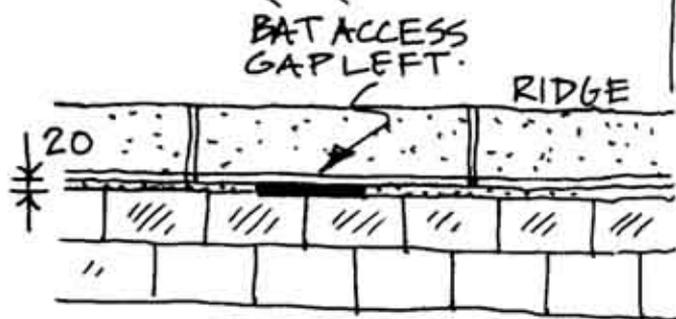
~ OPTION B ~

MAINTAIN 20MM MORTAR GAP. & LEAVE A SECTION OUT.

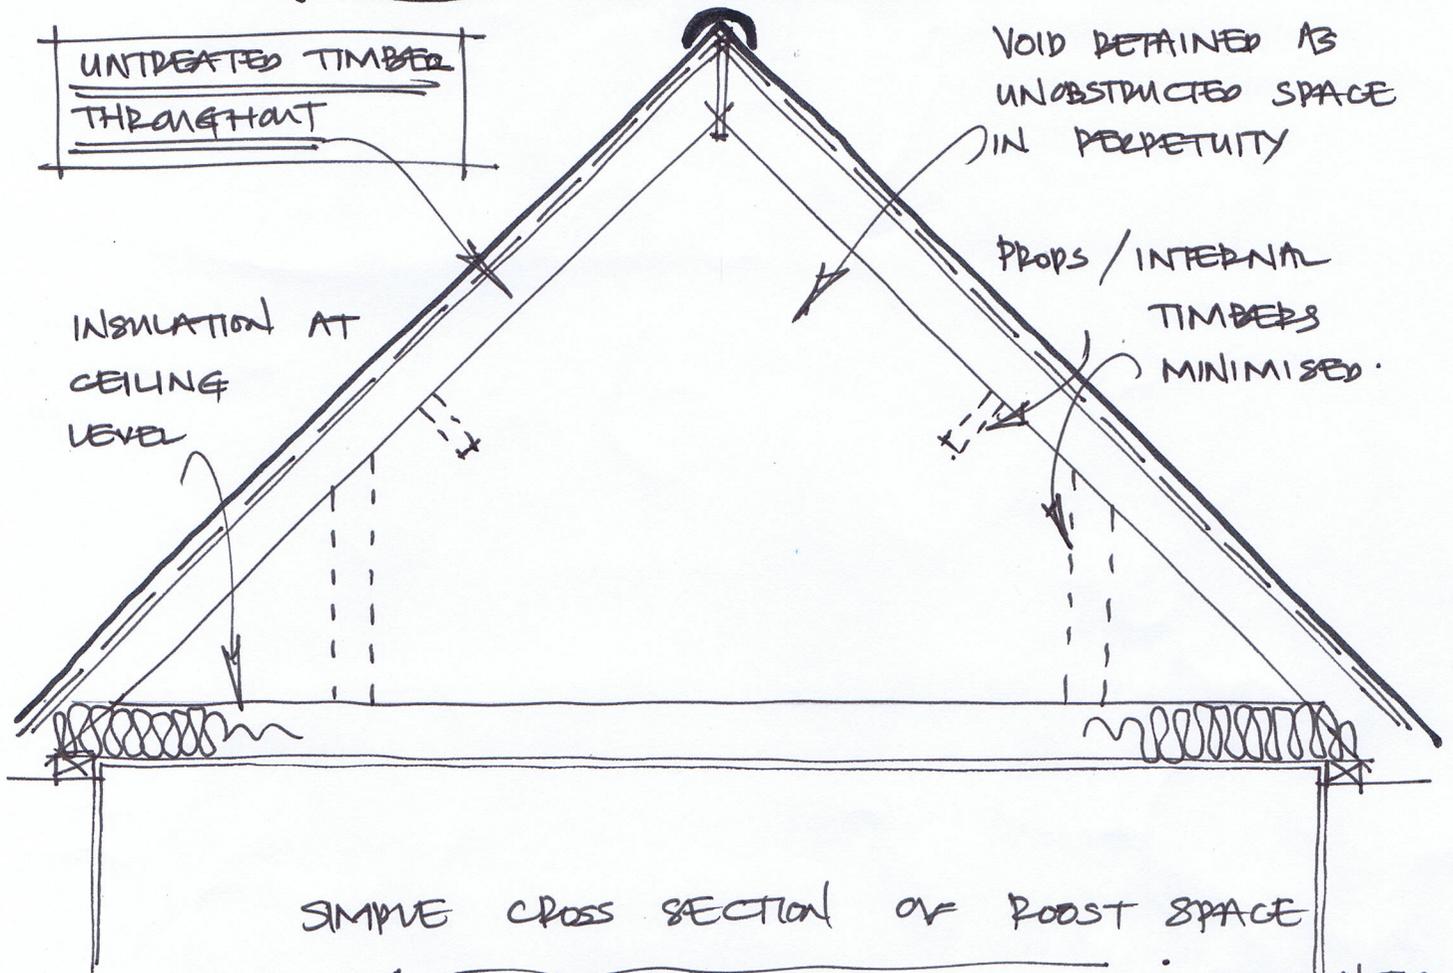
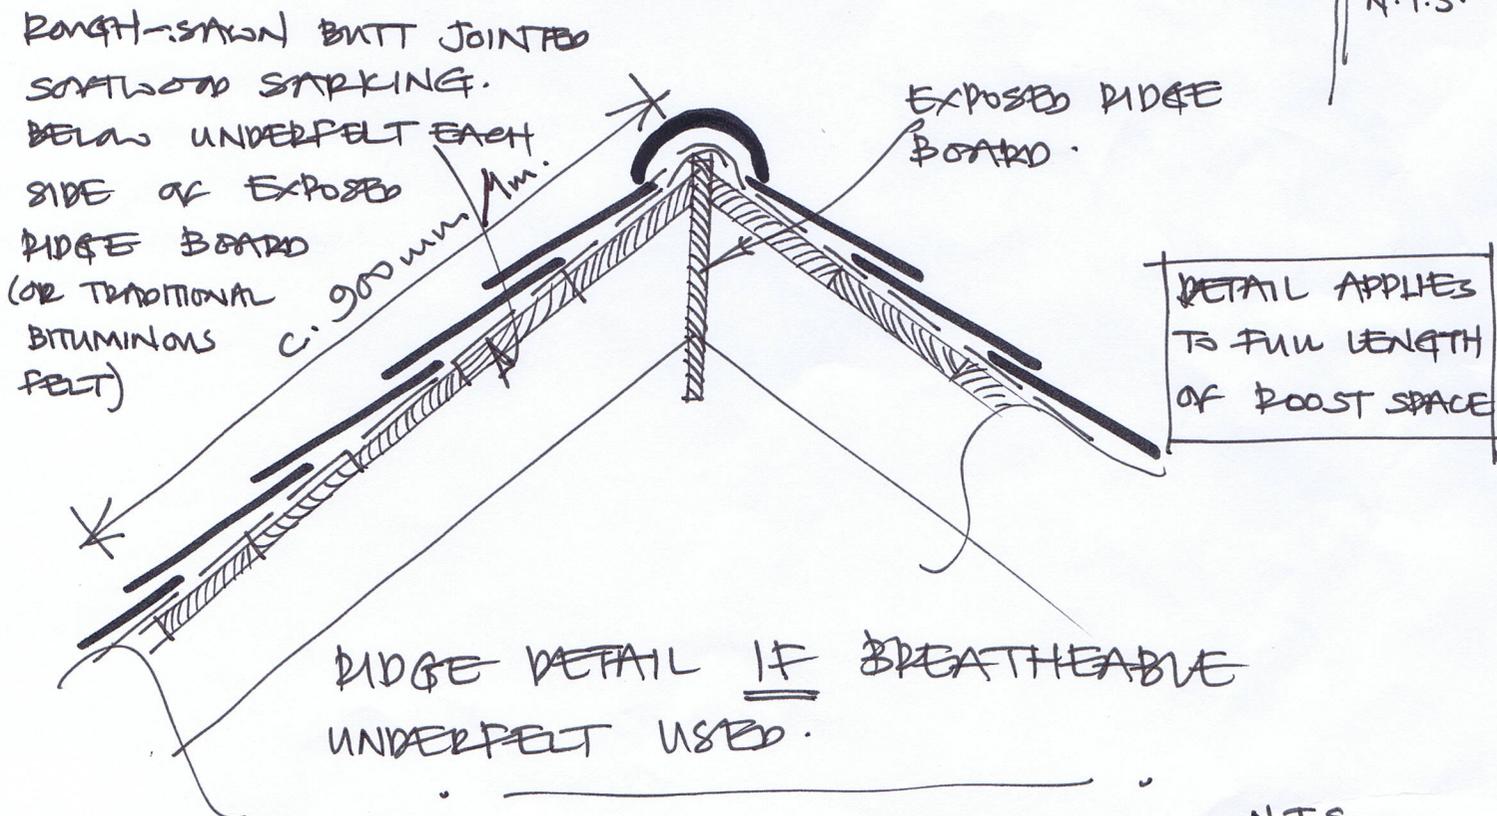
# BROWN LONG-EARED BAT

## ~ ROOST DETAILS
