2014-03(08)

30th September 2016

Re: Update of bat hibernation checks at Coventry Stadium, Warwickshire

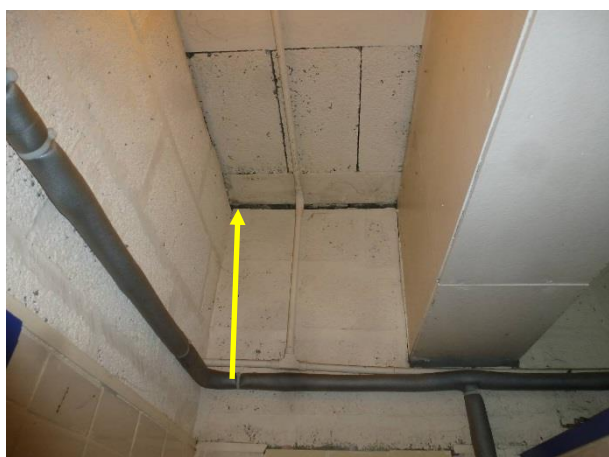
The inspection of the grandstand in January 2016 revealed a collection of c20 bat droppings on top of a brick wall in the ladies toilets of building 4. The droppings were small in size and appeared to be relatively fresh - either from recent weeks or the preceding autumn. A number of discarded butterfly wings were also noted on the floor below this roosting location as well as loosely scattered on the floor of the ladies toilets. It should be noted that this roost was not recorded during any of the previous bat inspections or bat activity surveys at the site during 2014.

Location of bat roost on top of wall in ladies toilets in building 4

- The loss of hibernation opportunities for roosting bats can be mitigated for via the provision of a dedicated bat hibernacula, the location of which is suggested within the woodland strip to be unaffected by the proposed development. The precise location of this would be agreed with the arboriculturalist to minimise any damage to significant trees, but is specifically suggested to be located here as it would be shaded on all sides by trees ensuring that it does not receive direct sunlight which could result in the internal temperature of the hibernacula being too warm. The bat hibernacula should take the form of a structure of minimum footprint 5m x 5m with thick walls of brick or stone that are enclosed (although access for bats could be provided via a grille opening on a door that was only accessible to a licensed bat worker for monitoring purposes). The building would be enclosed (i.e. not open-sided) and it would need no separate loft space as crevices would be created on the ground floor of the hibernacula within the walls and via the addition of Norfolk bat bricks (suitable for use by hibernating bats) - see enclosed information. The roof of the hibernacula should be of a design that would allow for a range of temperature levels within the building between 0°C and 10°C and to encourage humidity levels to be high (around 90% is ideal). A bare earth floor and locating the hibernacula partially underground will all help to achieve this.

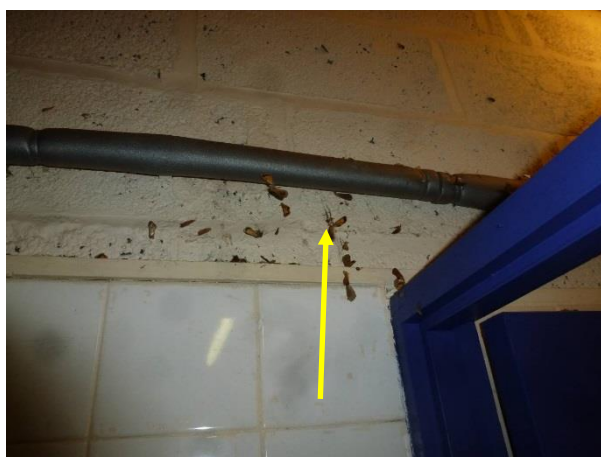
Location of discarded noctuid wings on wall of ladies toilets in building 4

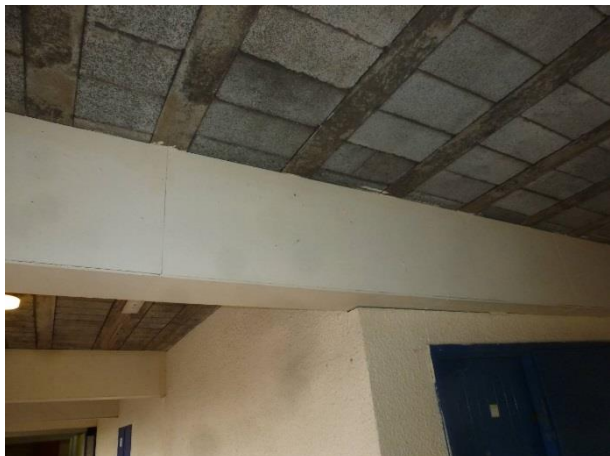
The location of these droppings was in a corridor that is open to the elements at either end and, as such, is subject to being blown about by the wind. As such, it is difficult to say with absolute clarity that the droppings were from a bat roosting in the gaps/void in the blockwork ceiling, although a precautionary interpretation would suggest this was the case.

Blockwork ceiling in corridor of building 4

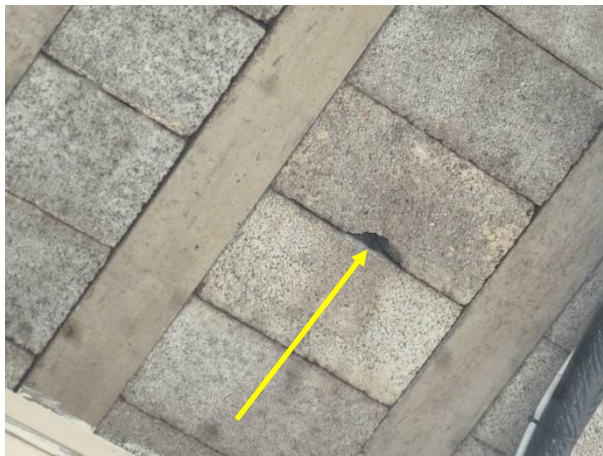
In the time between collecting the static bat detectors on 4th February 2016 and re-visiting for the second inspection on 19th February 2016, further evidence of bats was noted. This time it was located outside the entrance to the ladies toilets in building 4 and broadly beneath gaps between blocks in the ceiling, where the original hibernation potential was noted. These droppings were fresh and a similar size to those found in the ladies toilets.

Roosting opportunities above bat dropping location in corridor of building 4
