## Bat Assessment

Preliminary Roost Assessment & Roost  
Characterisation Surveys

Coventry Stadium  
Rugby Road  
Binley Woods  
Warwickshire

Brandon Estates Ltd

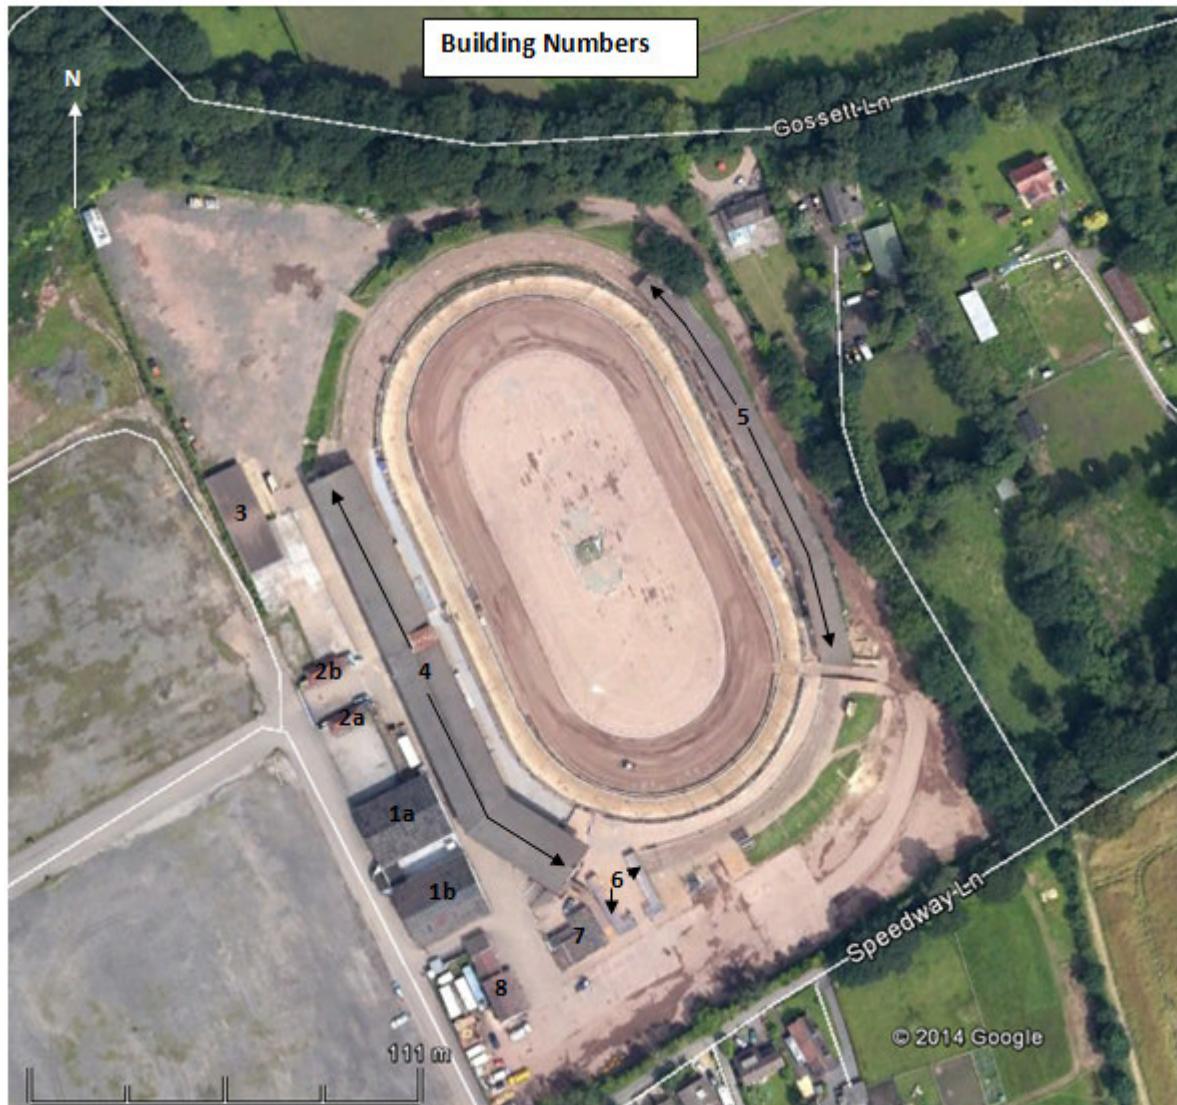
Figure 3: Building locations and numbers used in this report.

For ease of reference, each building was given a number, indicated on the following map (Figure 3) and is described below in detail.

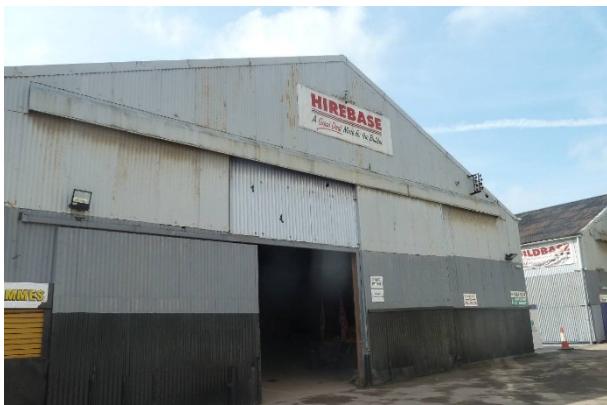
This building comprised two discrete areas 1a and 1b linked by the existing turnstiles. Each hangar building was at least two-storey high and neither had a separate roof void. They were steel-framed, with a pitched roof of profiled metal sheeting with integrated roof lights and were, in part, clad with blockwork. Building 1a benefited from some deteriorating linen cloth stretched across the eaves creating a makeshift roof void (possibly to prevent pigeon, and the like, from nesting or to offer protection from droppings) whilst building 1b was fully vaulted, although this building did have some dividing walls creating separate cells and some areas of the building were, therefore, darker than others.

*Building 1a - eastern external elevation*

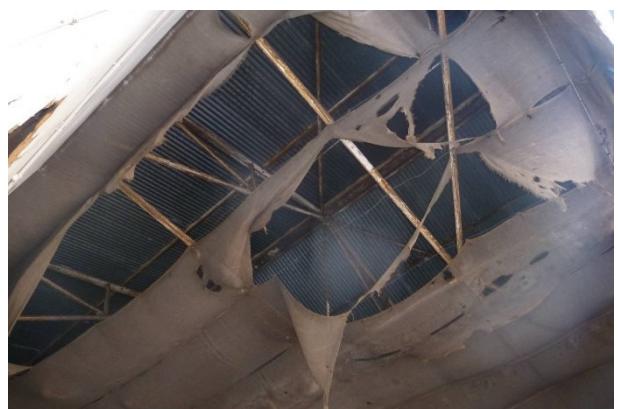
*Building 1a - internal*

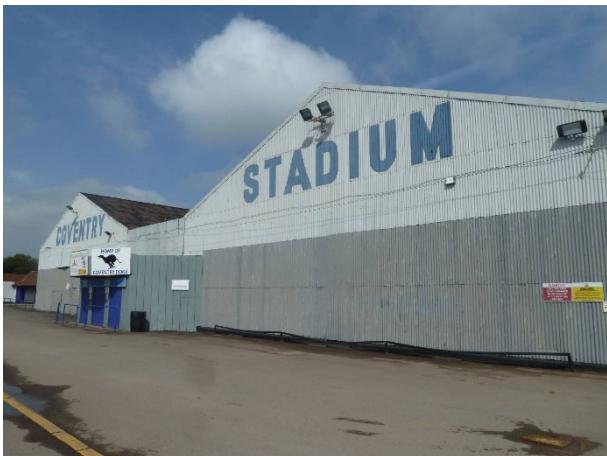
*Building 1a and 1b -western external elevation*

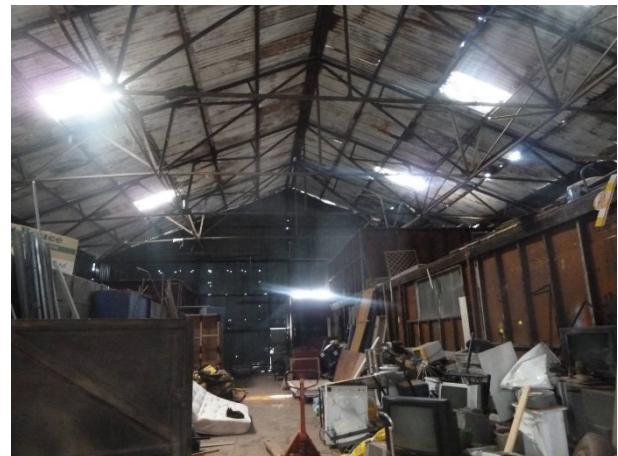
*Building 1b - internal*

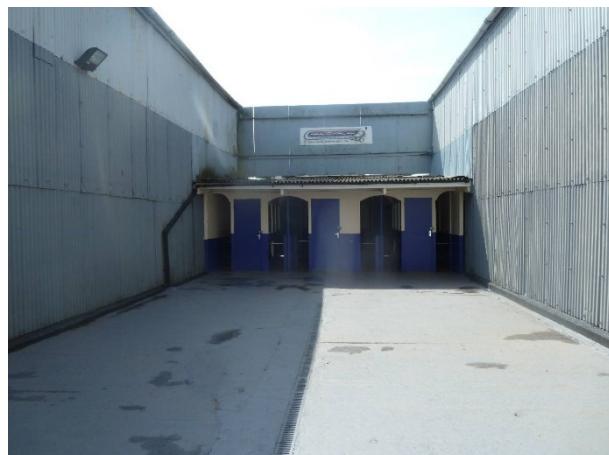
The turnstiles were open to their eastern elevation with a mono-pitch roof and a flat roof beyond this. Internally, a suspended ceiling was present beneath the flat roof, possibly resulting in a void between the ceiling tiles and the approx. 0.5m deep flat roof above.

*Turnstiles between 1a and 1b*

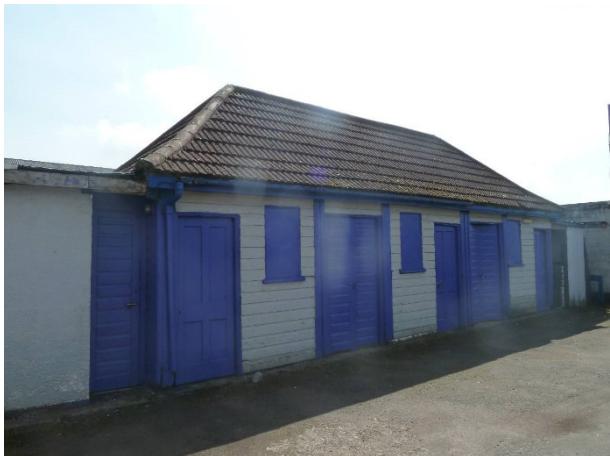
This comprised the former turnstile buildings, of which there were two: 2a and 2b. These were small single-storey structures, each with a separate roof void. 2a was timber clad whilst 2b was constructed in blockwork and both had a hipped roof finished with concrete interlocking tiles. In 2a, the loft hatch was open but access to this area by the surveyor, was hindered by the presence of stored barrels, although a roof underlining of bituminous felt was visible and appeared to be torn in places. In 2b, the roof void was accessible and was of a traditional purlin and rafter construction but with an underfelt to the roof of black plastic. The height of the roof void was approx. 1m from ceiling to ridge board.

*Building 2a - northern elevation*

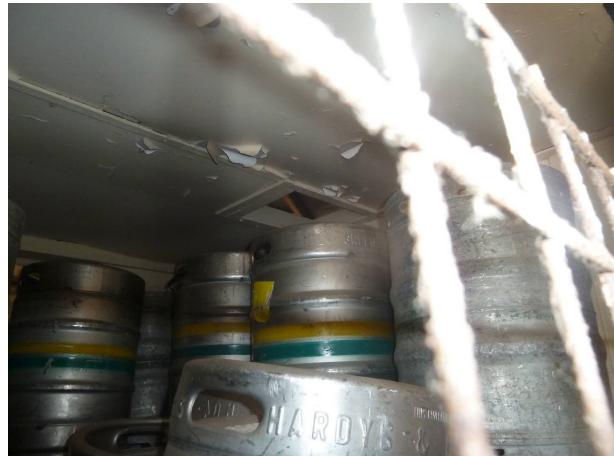
*Building 2a - internal; access to loft hatch was hindered*

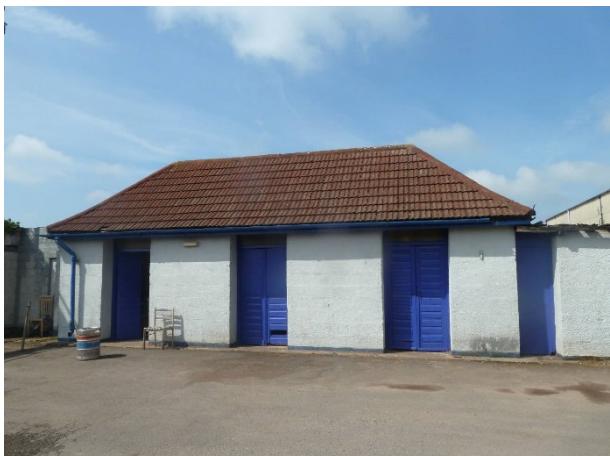
*Building 2b - southern elevation*

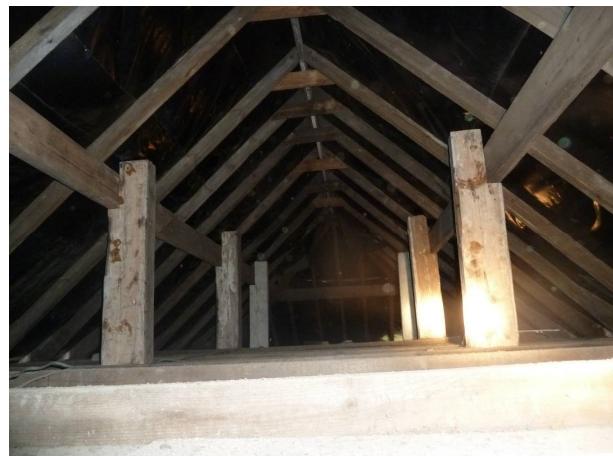
*Building 2b - roof space*

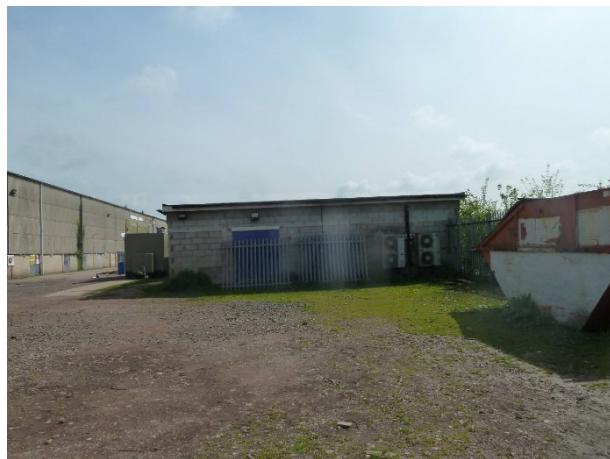
This comprised a large single storey building that was in use as holding kennels for greyhounds during the race days. It was constructed in blockwork and was partly timber clad. Its shallow pitched roof appeared to be finished with bituminous felt and internally a suspended ceiling meant no access to any roof void for the surveyor. However, removal of a ceiling tile revealed a timber deck to the underside of the roof and a maximum height of roof void of 0.4m.

*Building 3 - southern elevation*

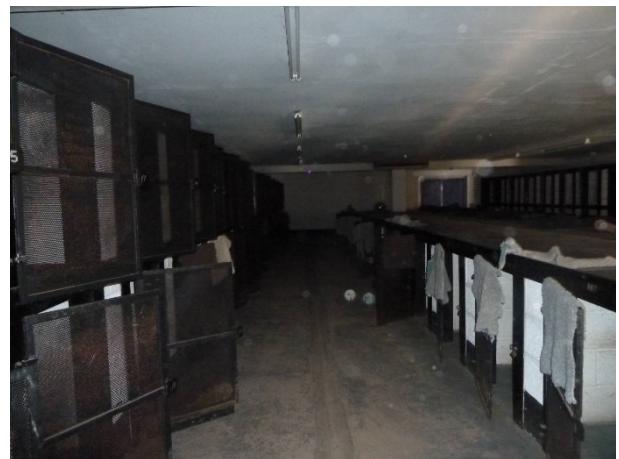
*Building 3 - internal*

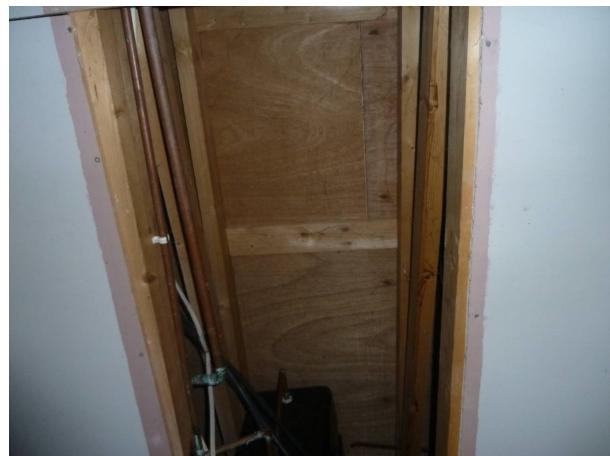
*Building 3 - sarking visible to underside of roof*

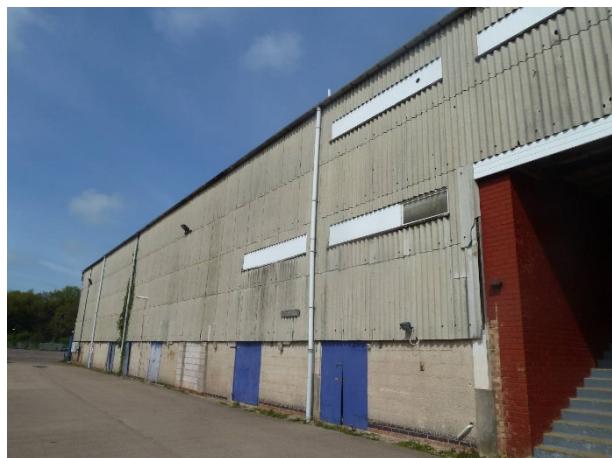
This comprised the main grandstand as well as the 'under stand'. The grandstand was an area of covered terraced steps with an enclosed glass viewing gallery with a flat roof and walls clad in asbestos cement. The monopitch roof over spanning the above was supported by a steel frame and finished with profiled sheeting. The 'under stand' area was located beneath the terraced steps and comprised a single enclosed space (accommodating seating and dining areas). It was constructed partly in brickwork and partly blockwork with an exposed soffit comprising a prestressed concrete beam & block floor above, and no windows. To access the main grandstand there were steps leading into corridors at the western elevation of building 3. The corridors were constructed in brickwork with a similar beam and block soffit above

*Building 4 - western elevation and stairs leading to corridor*

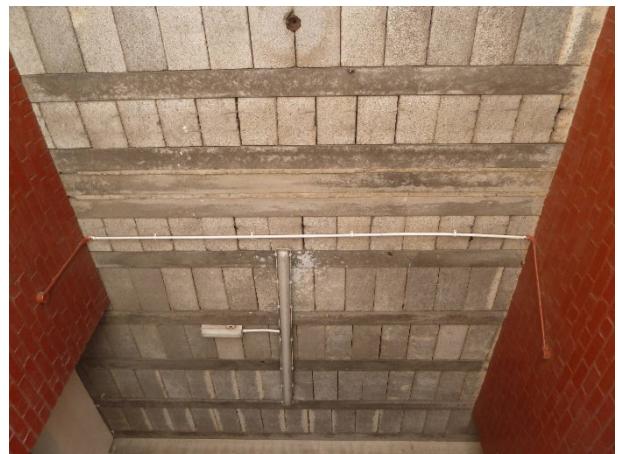
*Building 3 - corridor and ceiling*

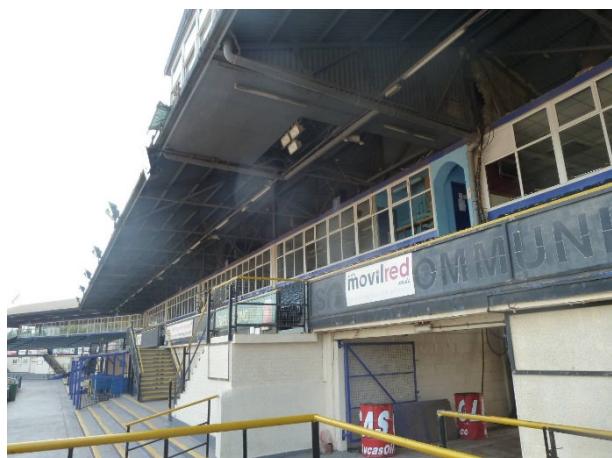
*Building 4 - eastern elevation showing terrace, steps and under stand below*

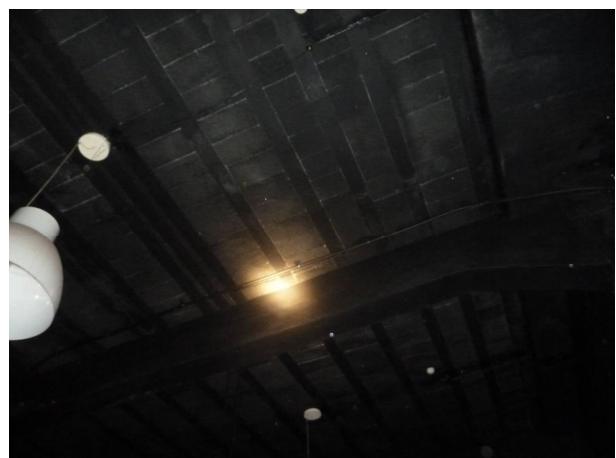
*Building 4 - soffit of under stand*

Building 4 appeared to offer moderate hibernation roost opportunities for bats during the winter months. Due to the potential extent of the cavities within the ceilings, it was not possible to undertake suitably thorough inspections of the building, although a check for bats in winter prior to development is recommended, it should be noted that an absence of bat evidence at this time would not necessarily represent an absence of bats. As such, it is assumed that such a building could house hibernating bats and a replacement hibernation building is recommended to be erected within the shaded woodland area. Further details and sensitive working practices are described in the sections below.

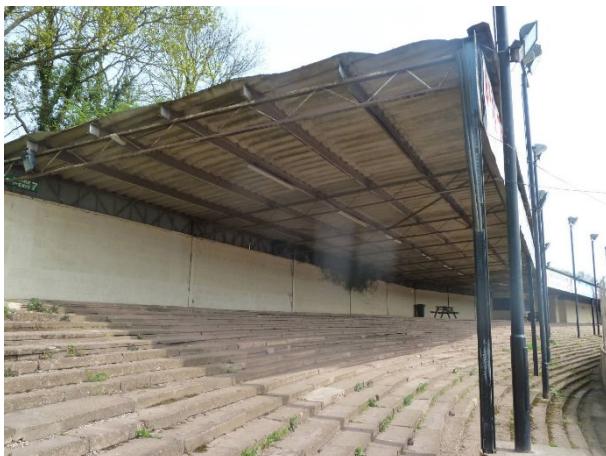
This comprised a covered terrace opposite the grandstand on the opposite side of the race track. A part timber and part steel-framed structure supported a monopitch roof of profiled sheeting, whilst blockwork cells housed separate male and female toilets. A boarded ceiling was present including below the monopitch roof over the terrace) and over the w.c. cubicles such that no roof void was present in this area, although in the area adjacent to the toilets, no ceiling existed, but fascia boards were present against internal blockwork walls.

*Building 5 - viewed looking south*

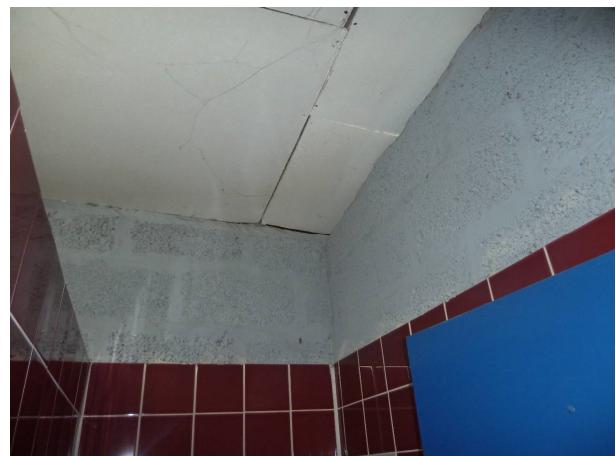
*Building 5 – internal - ceiling in toilet cubicles*

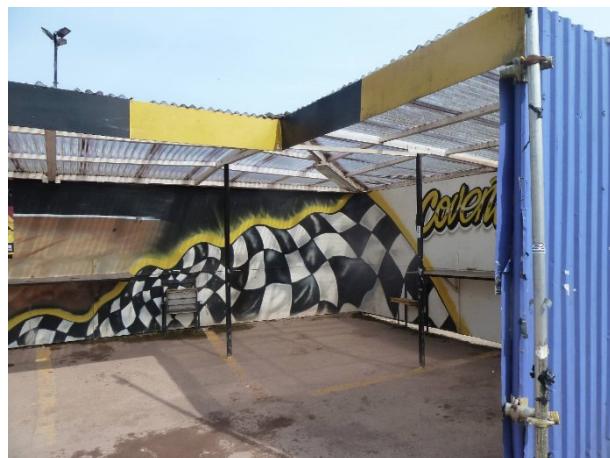
This comprised an area of single storey, monopitch, profiled perspex and profiled cladding construction with steel frames for use as cycle storage or similar.

*Building 6 - cycle storage*

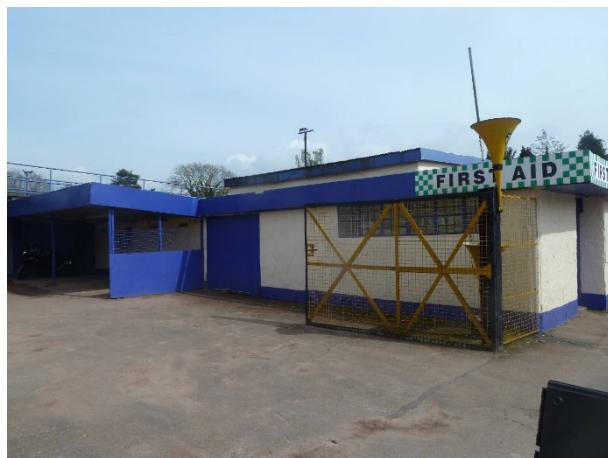
This comprised an office unit and first aid station and was only accessible in part to the surveyor at the time of survey. It was constructed in solid brickwork with a flat corrugated roof and its roof height was greater in the central area of the building. Internally, there was a boarded ceiling with no accessible roof void. Any void was likely to extend only to the depth of the roof joists.

*Building 7 - north elevation*

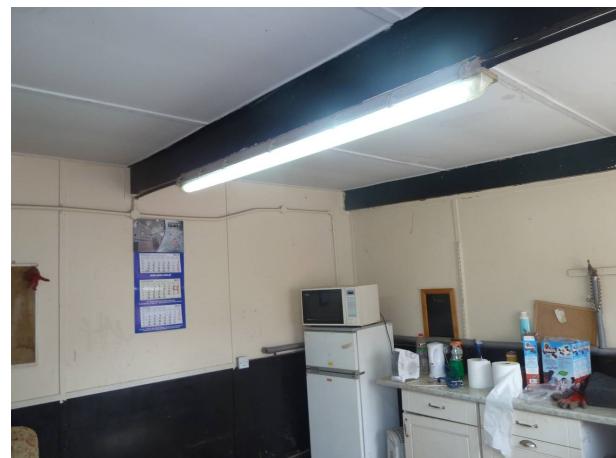
*Building 7 - internal*

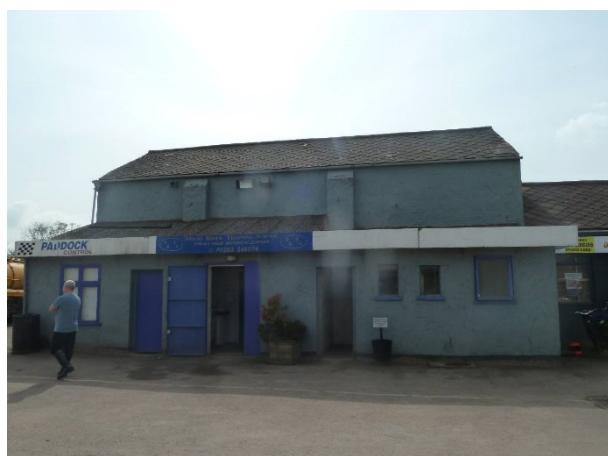
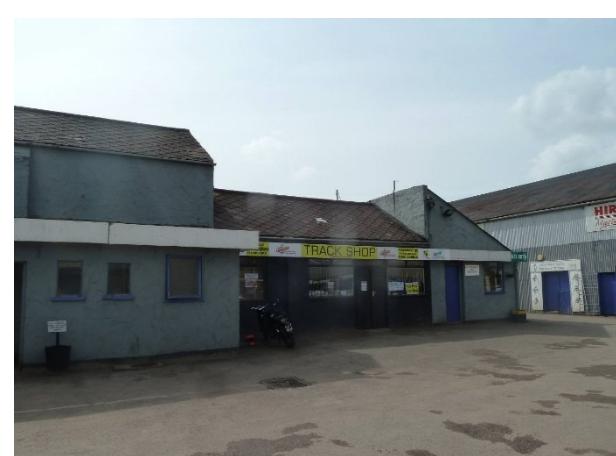
This comprised three adjoining buildings more akin to dwellings and containing stored materials, motorcycle learning centre office and a bike shop. All buildings were constructed in solid brickwork with a pitched roof finished with felt tiles in a diamond pattern. Lean-to elements were present to building 8a (housing a utility area) and internally there were boarded ceilings with no access to the small void above (likely to be no more than 0.3m deep). Building 8a was the two-storey element that housed a sub-station and a learning to ride office on the ground floor. Whilst an upper floor was present, this was not accessible as there were no stairs and the sub-station was locked at the time of survey. It was not known whether the upper floor was open to the ridgeboard or whether there was a separate roof void present.

*Building 8 - a, b, c from left to right*

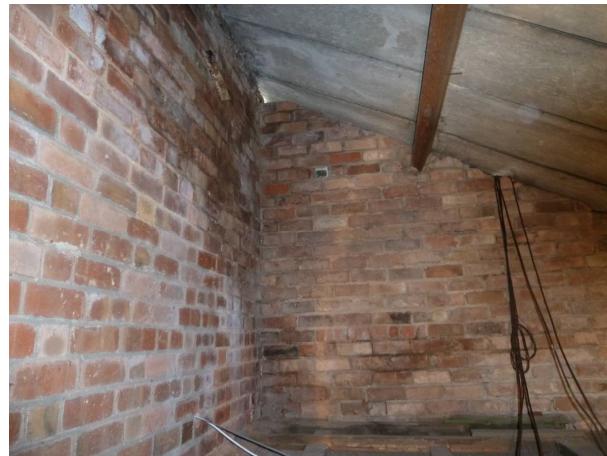
Building 8c was used as storage and access was gained via a loft hatch to the roof void above. The roof of this building was mono-pitched and timber rafters were present but with no lining to the roof. No insulation was present at ceiling level or between the rafters and the maximum headroom within the void was approx.1.6m where it adjoined building 8b.

*Building 8c - roof void*

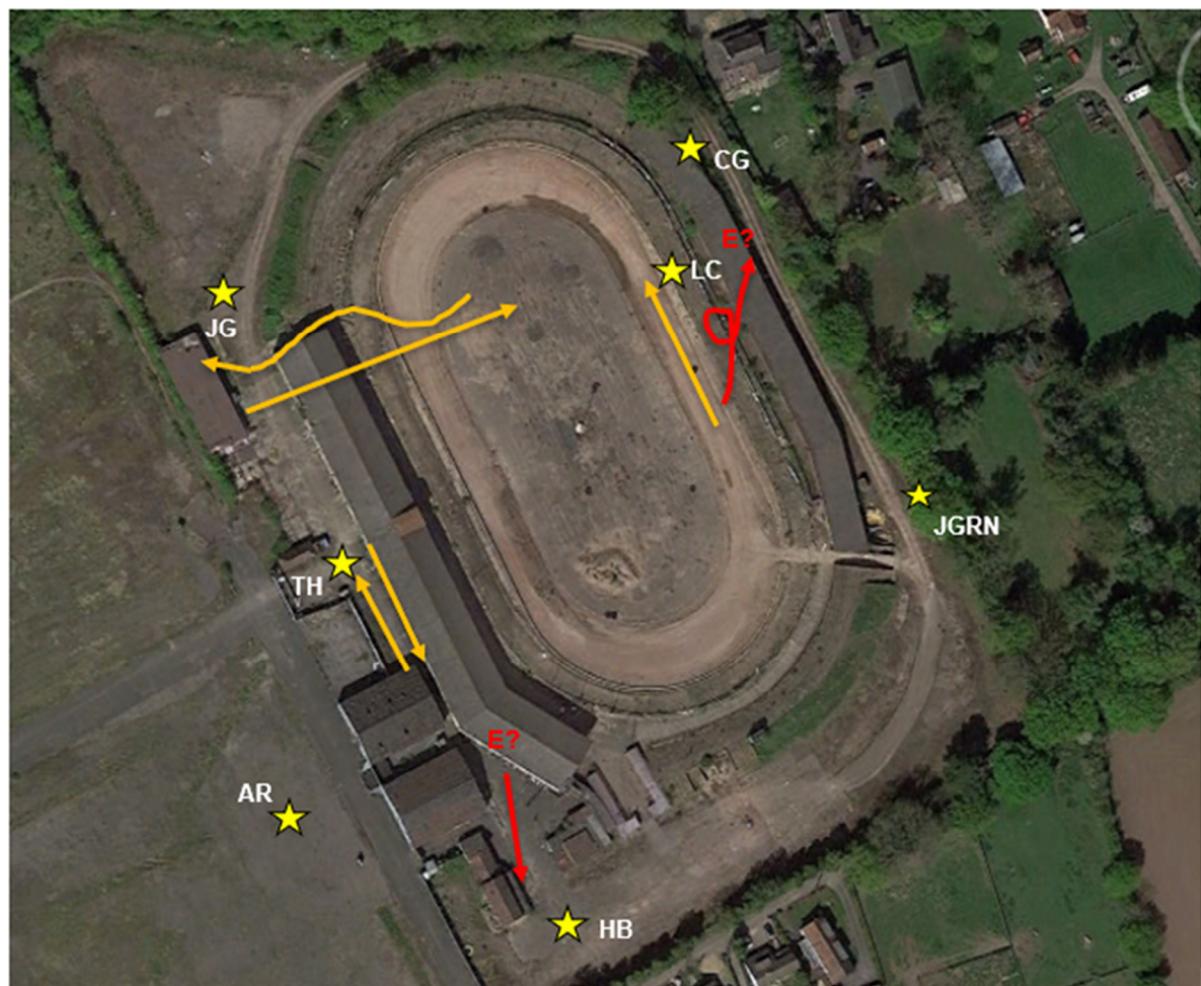
**Figure 4: Bat Activity Map- Dusk 15/07/2020****Project:** 2020-01(08)**Date:** 15/07/2020**Scale:** Not to scale 2020

Two common pipistrelle bats were noted as possible emergences adjacent buildings 4 and 8 but precise locations could not be determined. No other bats were seen to emerge from any of the buildings. The static bat detectors only recorded common pipistrelles which were noted to foraging and passing building 5 at the Site.

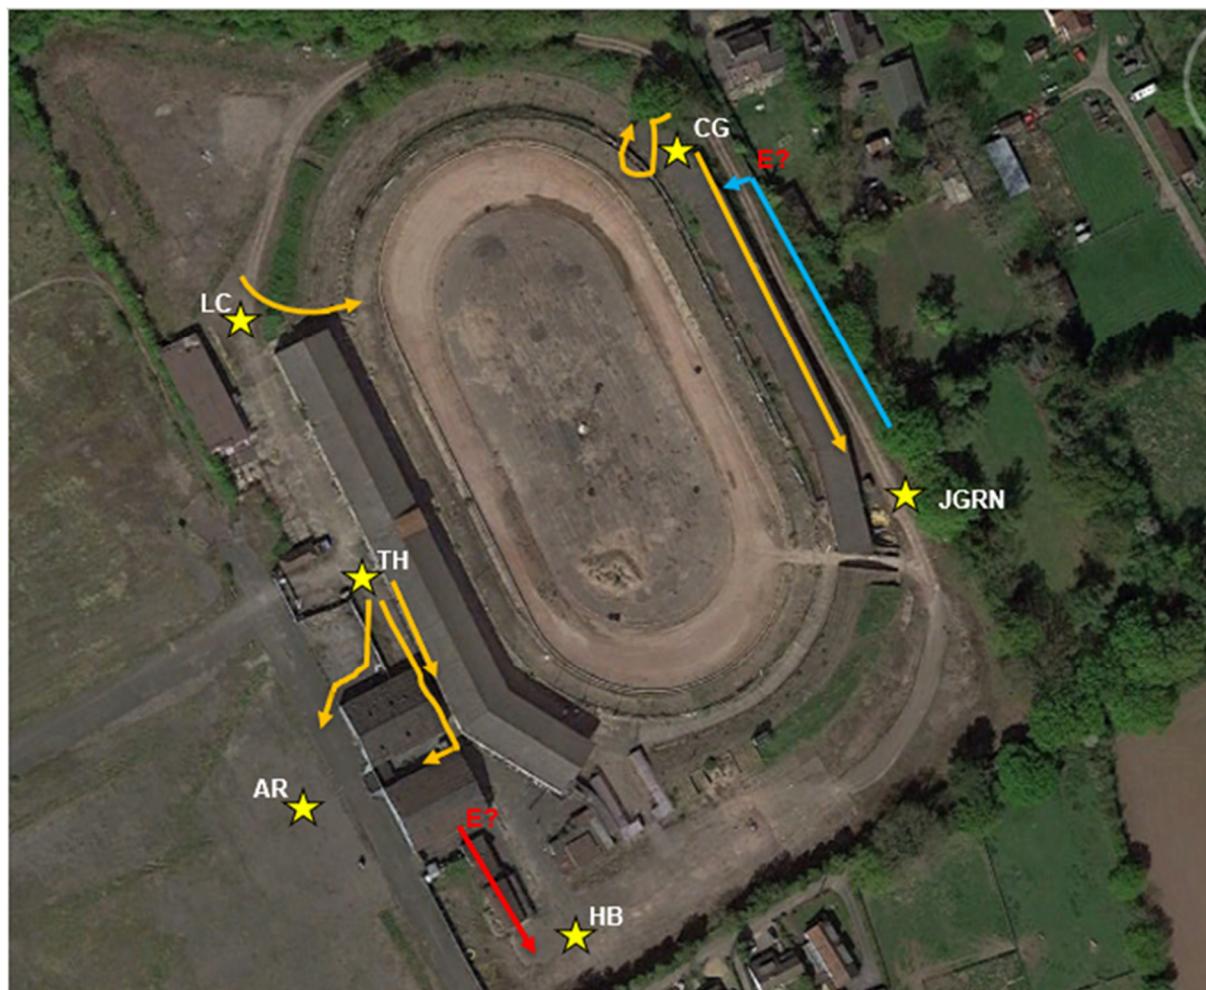
A single common pipistrelle was noted as entering building 8 during the survey at 04:21. With an addition common pipistrelle identified a possibly entering near the men's toilet block of building 5 at 05:09. No other bats were seen to emerge from any of the buildings.

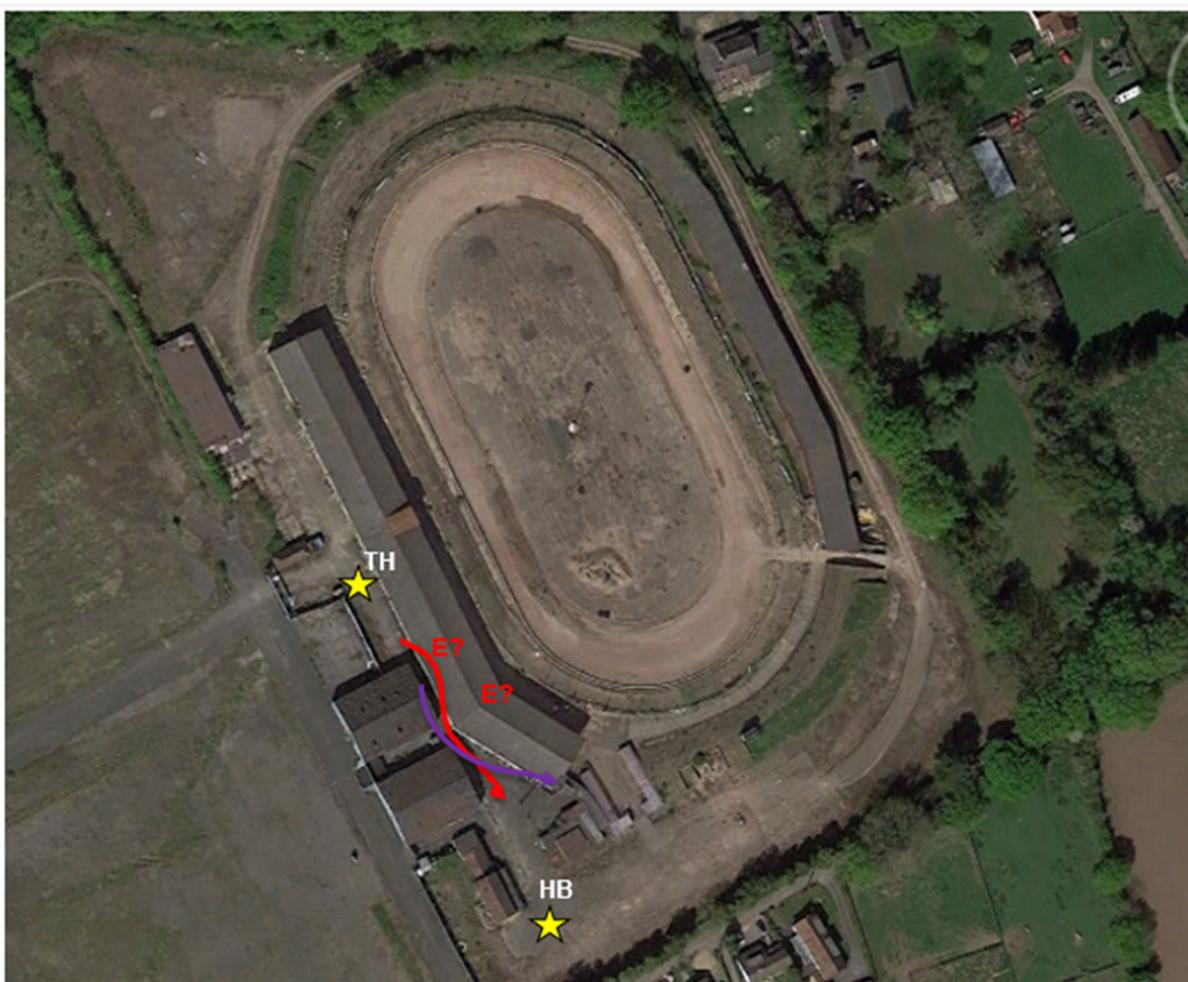
Observation of a single common pipistrelle was made at 20:54 possibly emerging from the western ridge of building 4. No other bats were seen to emerge from any of the buildings.
